# **Carnegie SVRA**

## **Storm Water Management Program**

### **2023 Annual Report**

**Date: March 2024**

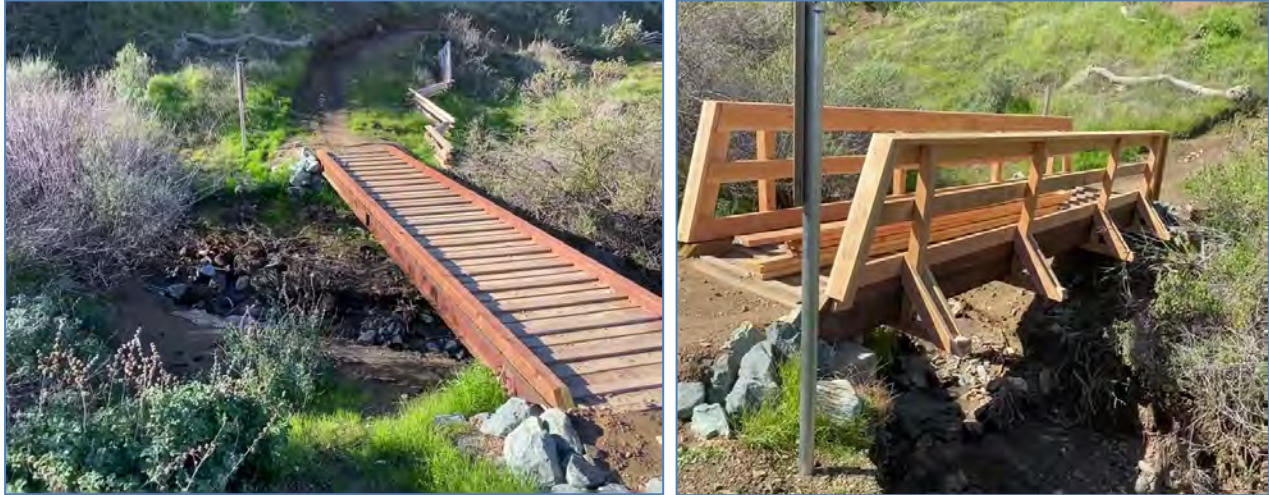
**Figure 2-19: Bunkhouse Bridge with Railing (Left) and without Railing (Right)**

quality, the Trails Team installed a bridge to allow riders to get across the drainage area without encountering the water below. The bridge was initially installed in November of 2022 with no side railings, since the bridge was not higher than 3 feet off the ground per OSHA standards. After the severe winter storms, the drainage under the bridge had incised and was now over 3 feet off the ground, prompting the installation of side railings. This bridge is the first of its kind at Carnegie SVRA and is only open to motorcycles.

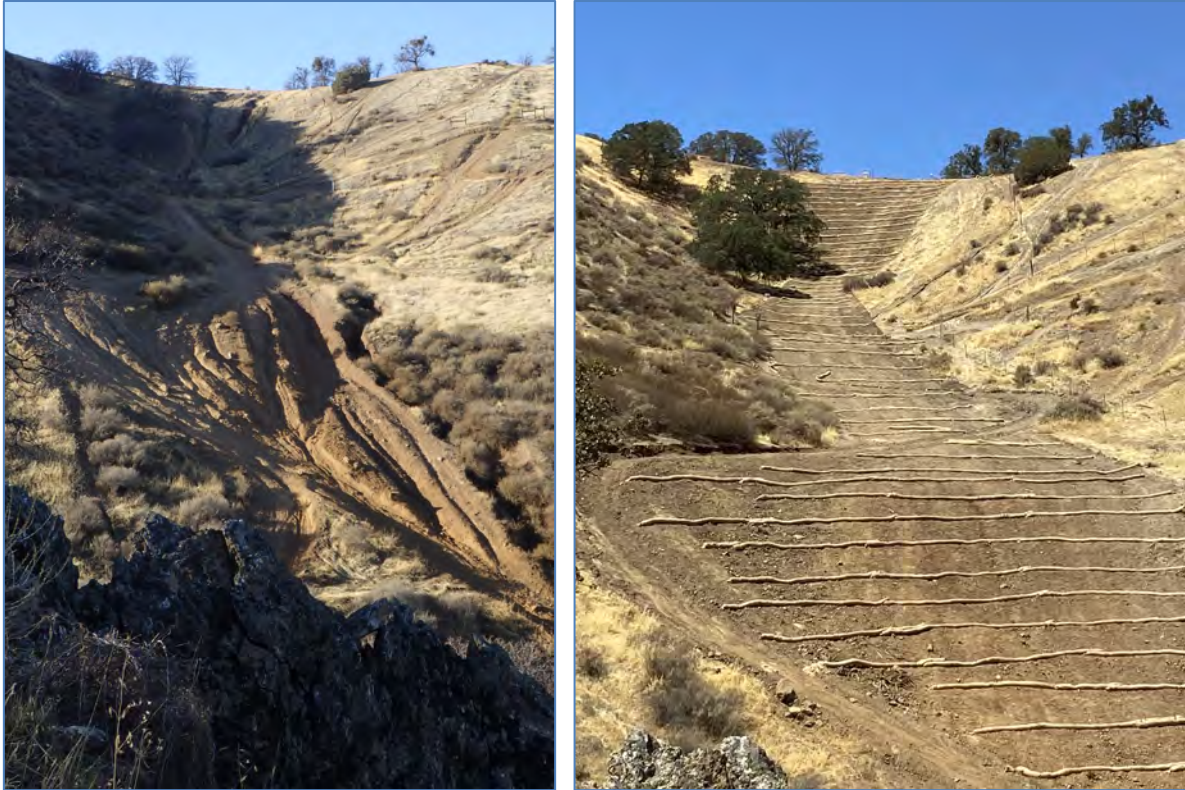
**Figure 2-20: Kiln West Hillside Before (Left) and After (Right) Rehabilitation Efforts**

The Kiln West Erosion Repair project is a three-phase rehabilitation project to repair a hillside area that was burned in the 2019 Hollow Fire to prevent potential soil loss and improve the habitat for wildlife. The project involved adding fill to return the hillside to grade, then installing storm water BMPs on rehabilitated areas after repairs were conducted. Phase 3 of the project was completed during Year 9, while Phase 1 and Phase 2 were completed during Year 10. The project area was surveyed for sensitive resources prior to the start of the project and the project area was surveyed each morning by the Environmental Scientist prior to the start of construction activities each day. Construction biomonitors were trained and remained on site during construction activities, and the Environmental Scientist was on-call for consultation during construction activities. Worker awareness training was held for each employee who worked on the project. Biomonitoring notes are available in Appendix E. The project included the installation of stormwater BMPs such as installation of straw wattles and hydromulch and native grass seed application on project areas once they have been rehabilitated for each of the three phases.

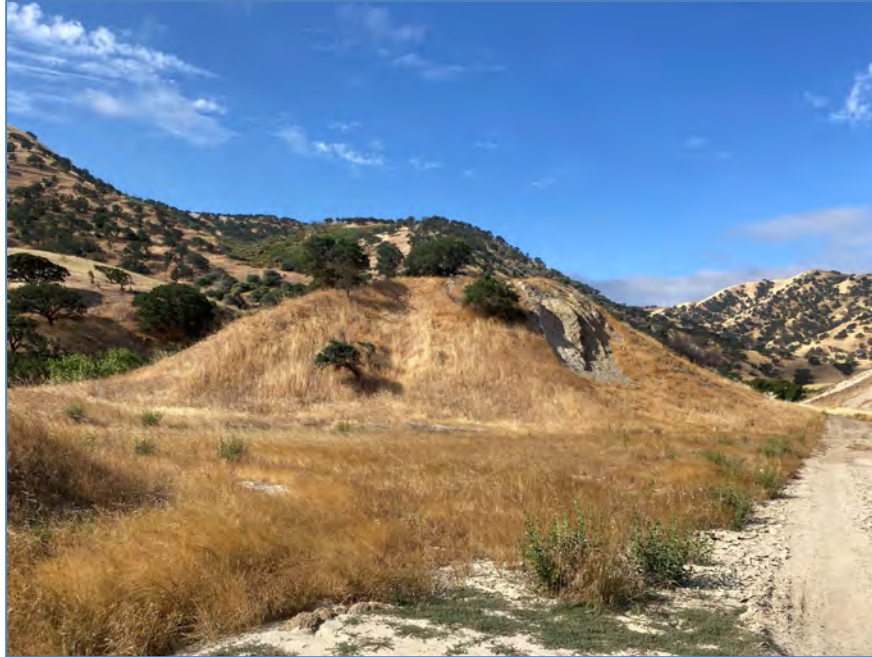
**Figure 2-21: Waste Rock Piles (May 2023)**

Previously, portions of the waste rock piles were covered with compost and hydromulch. The compost application that was implemented in late 2013 continued to support vegetation even after a fire had burned portions of the composted area. An additional 1.42 acres of tailing was covered in compost during the 2019 reporting cycle. In addition, approximately 600 feet of silt fence was installed to help capture sediment from entering the creek. Longer term BMPs are still being evaluated and scoped.

In June 2022 (i.e., during the previous reporting cycle), there was another fire that burned the waste rock piles. The BMPs were replaced after the fire and inspections continued quarterly. The rock piles continue to support vegetation.

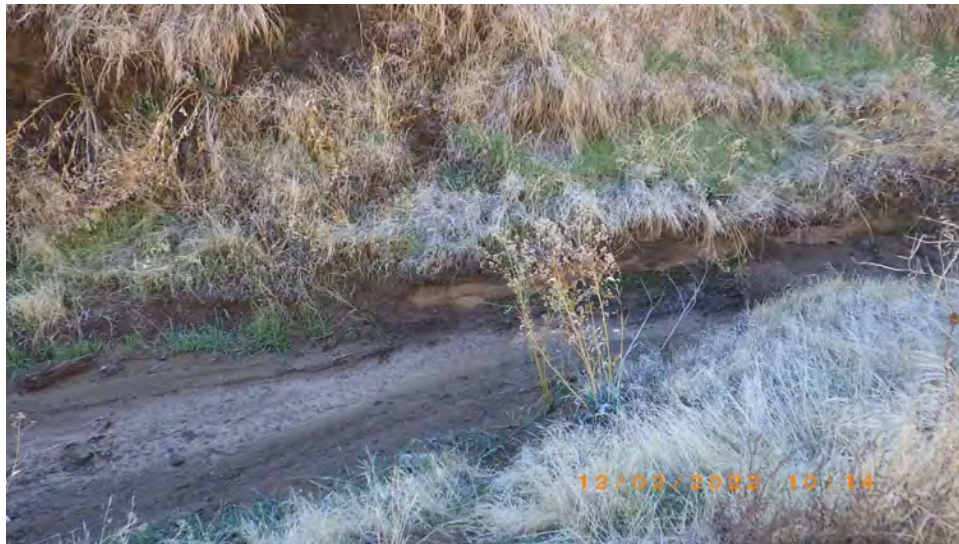
Photo 3: Tyson out. No flow, no sample taken.

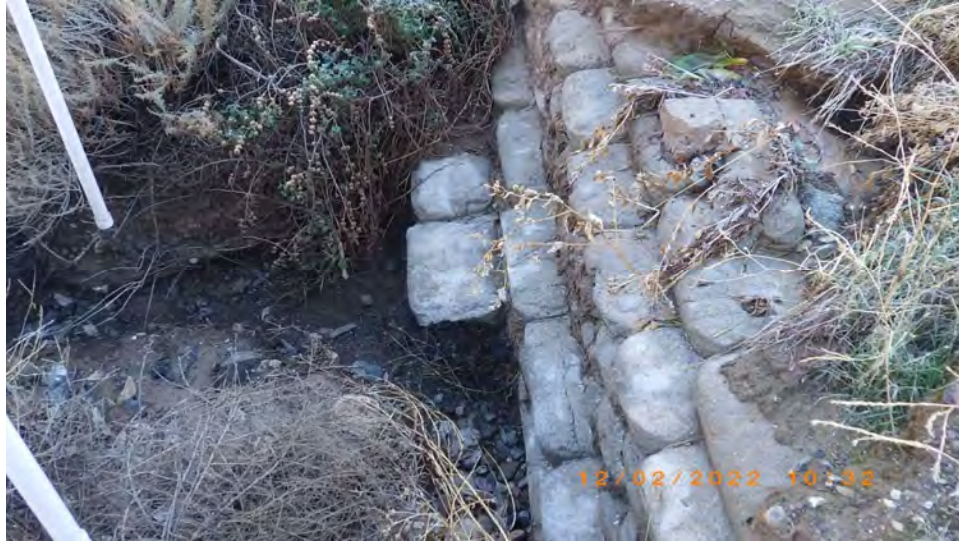
Photo 4: Carrel in. No flow, no sample taken. Photo for Carrel out is missing, but there was no flow and no sample taken.
