National Register of Historic Places Registration Form

Historic name: Kelso Depot, Restaurant and Employees Hotel (Boundary Increase II)

Other names/site number: Kelso Historic District (Boundary Increase II)

Street & number: Mojave National Preserve (MOJA); Kelso-Cima Rd (0.29 mi NE of Kelso Depot)

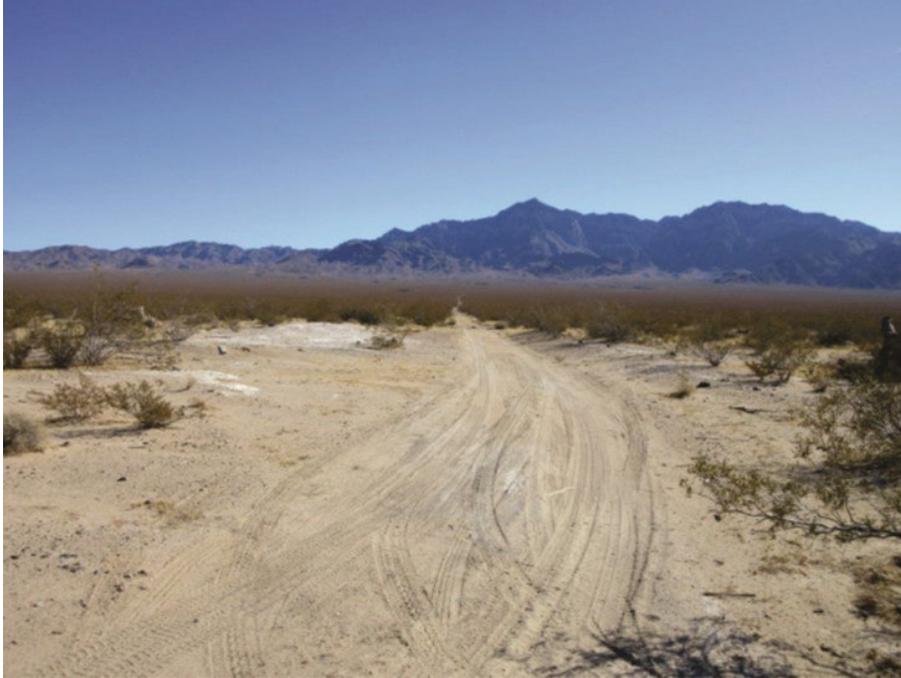
Photo 1 Two track road, facing east

Likely constructed in the earlier period of development of the Kelso area for its water resources (1904-05), this dirt access/service road, 9 ft. wide by 5.7 miles long, is simply scraped away/cleared into the surrounding alluvial limestone plain heading southeast at an upward two percent slope into the Providence Mountains toward Cornfield Spring. The road served as an access and service road for maintenance of the reservoir, pipeline, and associated water conveyance features bringing water from the Cornfield Spring source to the Kelso Depot area providing water for the town and the steam engines.

The road's overall condition is good and reflects what most likely would have been its condition during the years of active use. Some signs of deterioration are present as in washes and drainage crosscutting due to yearly rainfall events. The road is still used for offroad recreation.

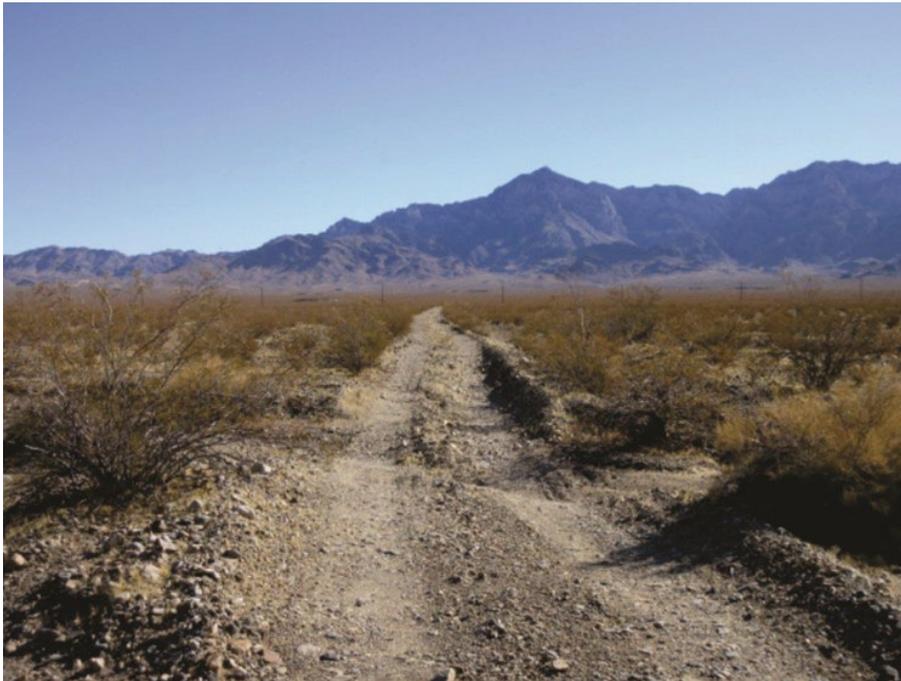
Photo 2 Pipeline, facing west

Likely constructed in the earlier period of development of the Kelso area for its water resources (1904-05), this heavy iron pipe and pipeline, 1 ft. diameter (pipe) by 5.8 miles long, is laid atop, and sometimes partially covered over with, the surrounding alluvial limestone plain heading southeast at an upward two percent slope into the Providence Mountains toward Cornfield Spring. The pipeline feeds from the reservoir (R3) to the Kelso townsite and from the reservoir to a spring box (R4), and thence to the source spring box at Cornfield Spring (R5).

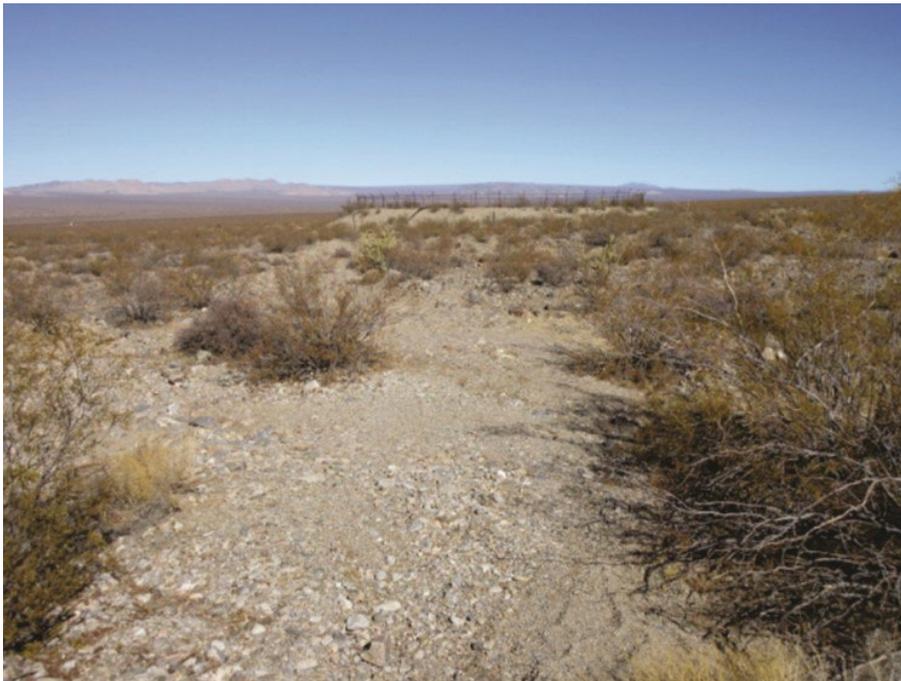
Photo 4 Pipeline, facing east

The pipeline's overall condition is poor to fair with some areas of pipe removal and staging (**Photo 4**) and some examples of upright venting pipe for the release of pressure as water is gravity fed downslope (**Photos 7-8**). In places the pipe has been displaced by seasonal flooding and broken likely as a result of rock-fall.

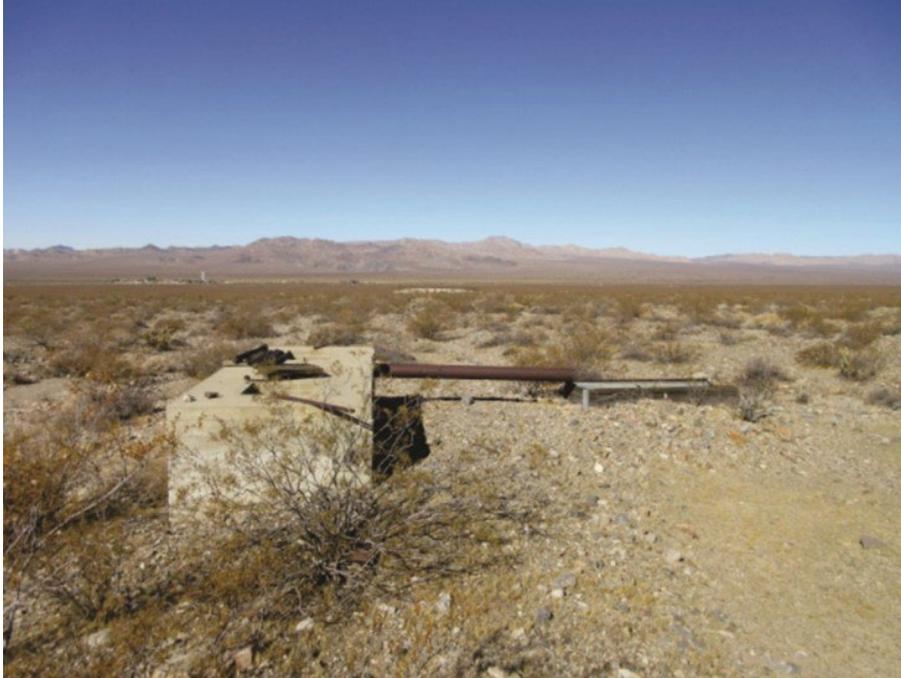
Photo 7 Reservoir from a distance, facing northeast

Measuring approximately 135 ft. in diameter, 417 ft. circumference, and 15 ft. deep, the reservoir is constructed of concrete with an outer soil fill. This structure was likely constructed 1904-05. The interior has 45 degree inward sloping walls for water storage. The 1 ft. iron pipe (R2) enters from the upslope east at the lip of the reservoir and exits out of a central drain on the bottom of the structure. An 8 ft. high fence surrounds the entire feature, mounted on the top lip of the reservoir. The structure is in good shape and could hold water again.
