National Register of Historic Places Registration Form

Historic name: Briggs Mansion DRAFT

Street & number: 2015 21st Street

City or town: Sacramento State: California County: Sacramento

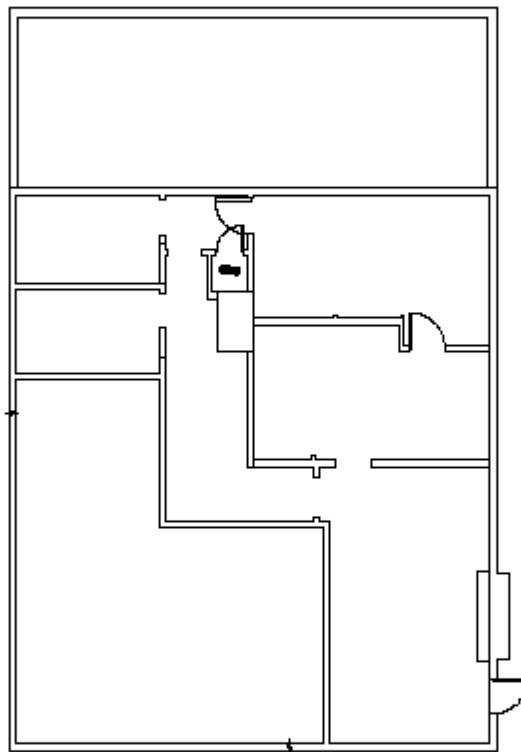
BASEMENT PLAN
SCALE: N.T.S.

The basement is largely inaccessible due to the condition of the staircase. The basement floors and walls are concrete and brick. A large portion of the north and west of the basement is a crawl space. Beyond this, there is a hall running east-west with office spaces and a mechanical room flanking the hall.

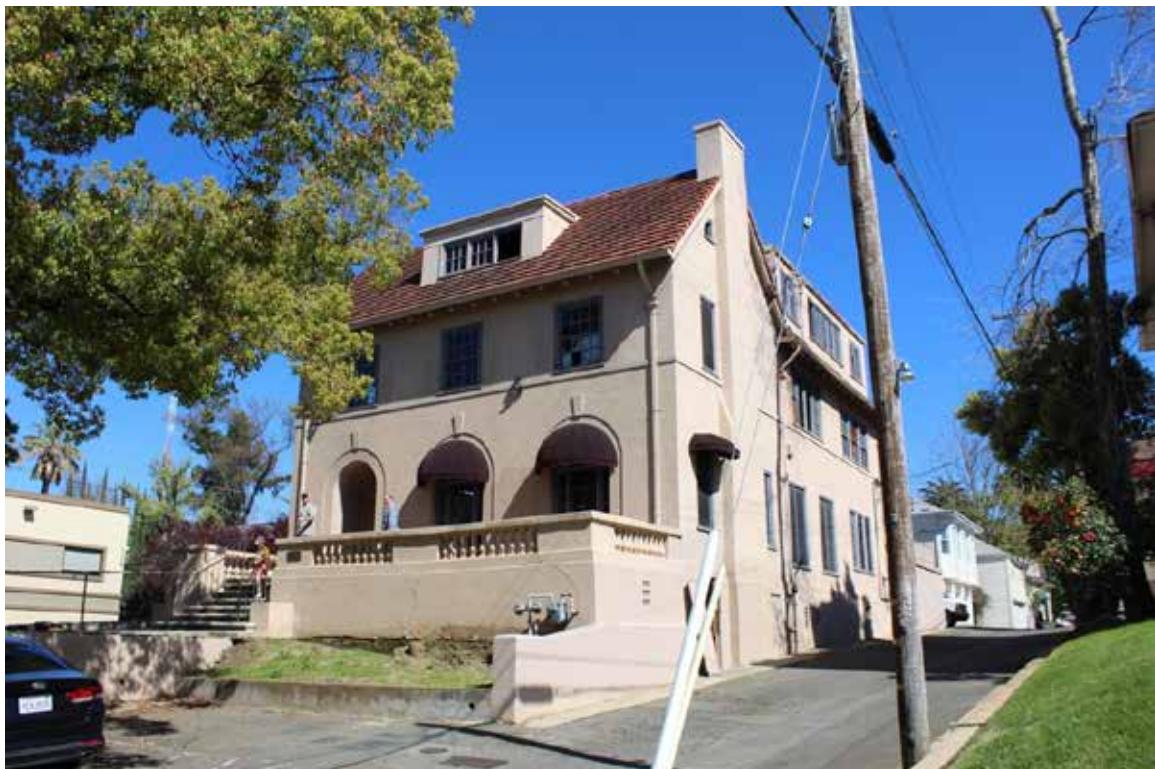
No. 001: West and South Elevations of Briggs Mansion, looking east.

West and South Elevations of Briggs Mansion, looking east.

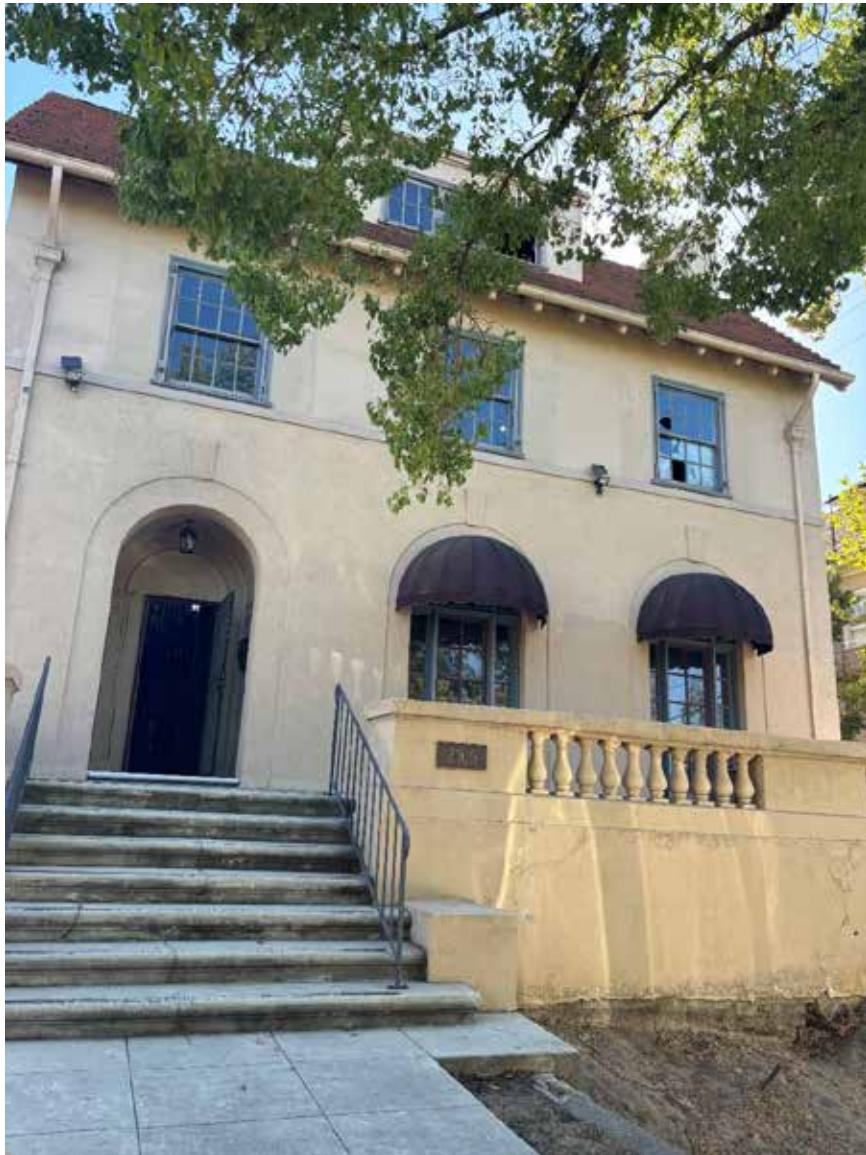
No. 002: West Elevation of Briggs Mansion, looking east from the sidewalk.

The primary (west) façade is symmetrical. The first floor has three bays of arched openings with decorative keystones. The northmost opening is recessed with a barrel-vaulted entry that contains the main door surrounded by decorative wood moldings and low relief false columns. The other two openings feature full height arched-topped wood windows. The southeast window is original to the mansion, however the southwest window is a replica of the original. The central sashes are two by five lites tall, and the side sashes are one by five lites tall. A painted concrete sill runs along the length of each window opening. The window openings are topped with rounded fabric awnings matching the curve of the arched openings.

A decorative band separates the first and second floors on the primary façade. Three symmetrical wood windows are centered over the first-floor openings, continuing the symmetrical three-bay appearance. The rectangular wood windows are double-hung, eight-over-eight lite sashes with painted wood moldings and sills. Hardware attached to the window trims as well as ghosting on the façade indicate decorative shutters were present at one time. A half-round gutter leads into rectangular downspouts flanking the north and south ends of the primary façade. The gutters have decorative sheet metal leaders and metal brackets fastening the gutters to the building face. The third-floor dormer at the primary façade is positioned over the central bay and matches the aesthetic and finishes of the façade below. An opening contains three wood awning-style window sashes with six lites each. The fourth-floor façade is not visible from the street, however it contains a window and an access door to the small terrace.

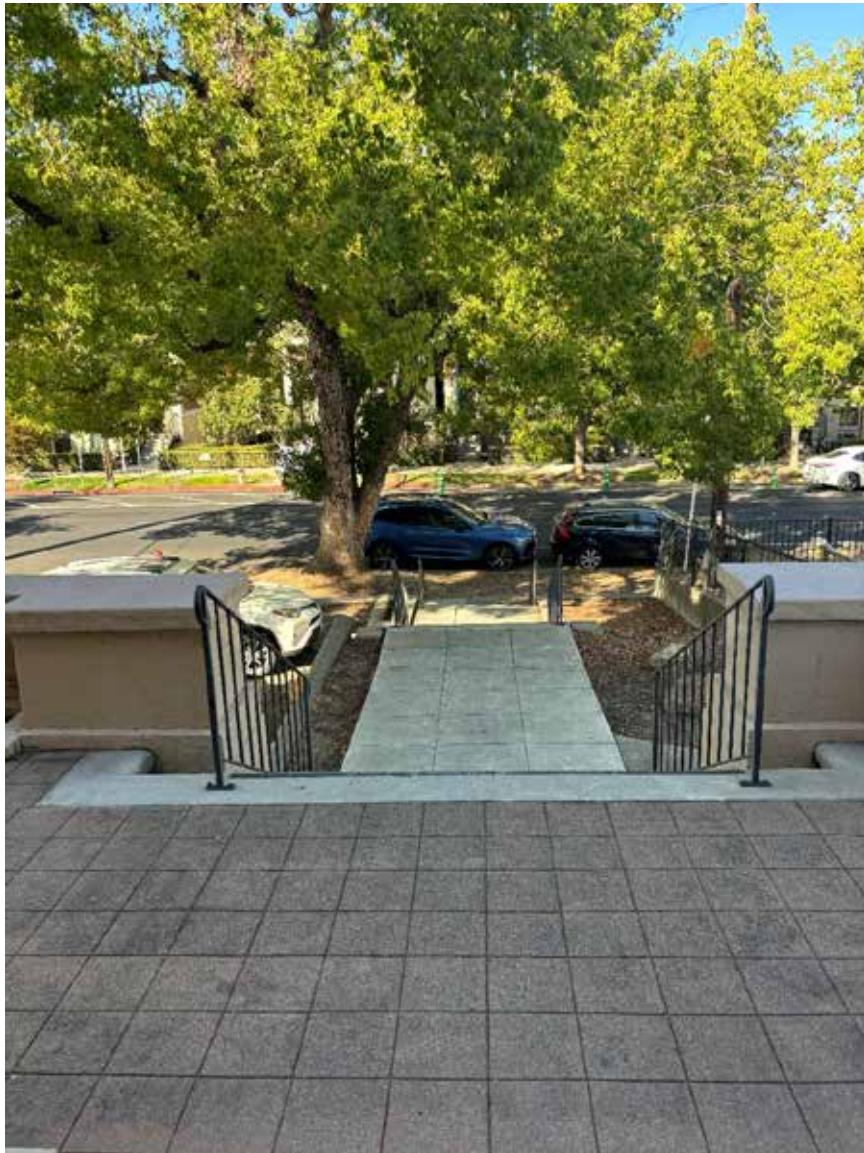
No. 003: Entry porch looking towards 21st Street, facing west.

From the sidewalk along the primary facade, the mansion is approached via a wide concrete stair with painted concrete sidewalls and iron handrails. The three-tiered stairs align with the northmost bay of the building and terminate at the entry porch. The entry porch spans the length of the primary façade. An open concrete balustrade with decorative balusters encloses the perimeter. The floor surface is integrally

colored and scored concrete to resemble the pattern of a square tiled floor. The uncovered stucco porch with ornamental balustrades, along with the tiled, side-gabled roof and stucco exterior suggests Italian Renaissance influences.

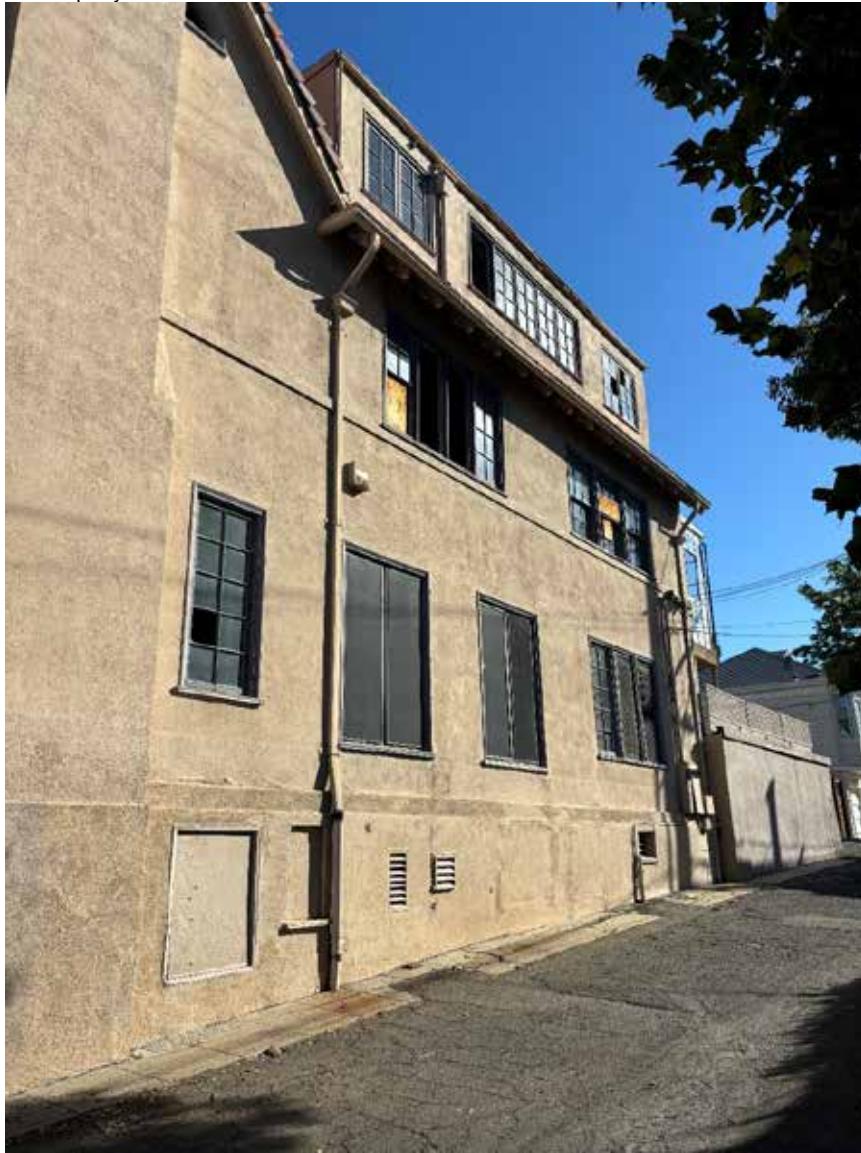
No. 004: South Elevation east massing, looking northeast.

The eastern mass of the cross gable contains five bays along the secondary façade. The first floor displays two matching wood casement windows along the first two bays, two lites by five lites at each sash. The third bay contains a three-sash casement window, also two lites by five lites, but with a higher sill level than the adjacent windows. The west bay of the second floor has a four-sash window, with many missing sashes. The east bay contains window opening with three double-hung six over six lite wood windows. The third-floor dormer displays three bays of casement windows: a central opening with

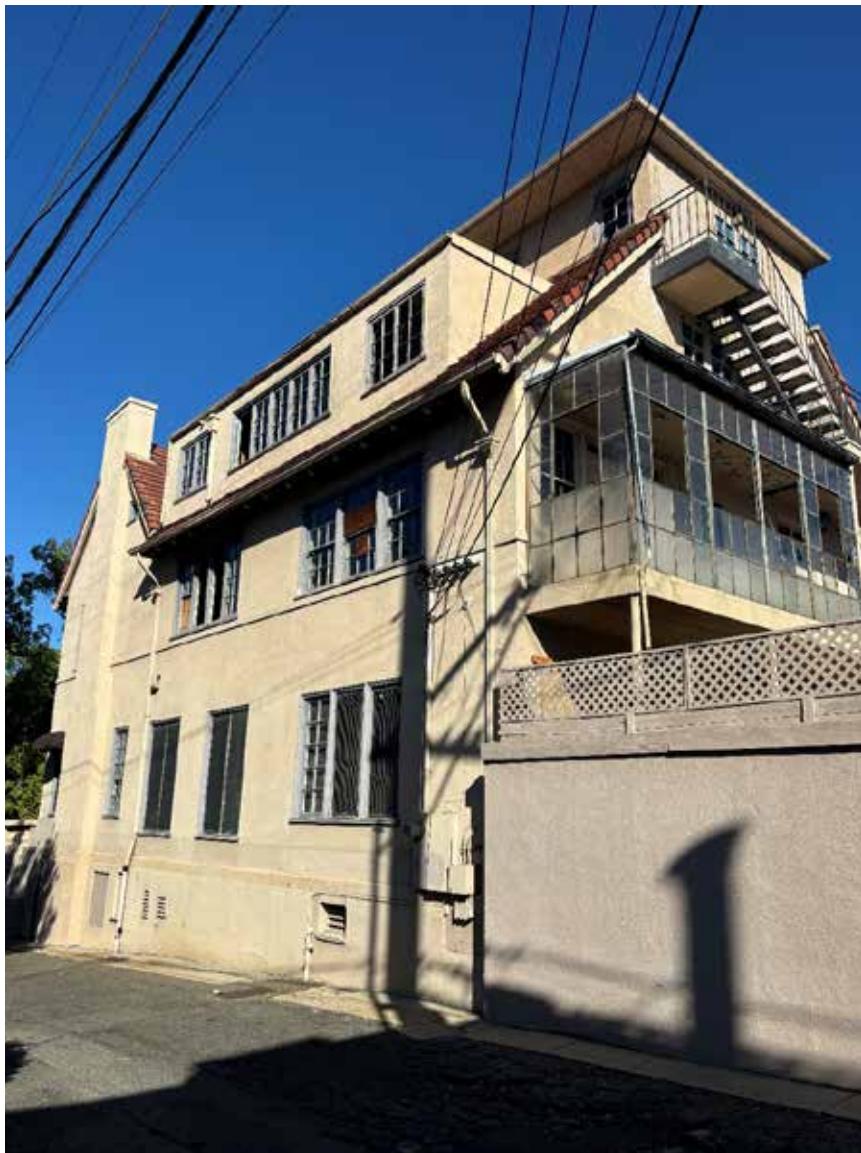
No. 005: South Elevation, looking northwest.

The secondary façade of the mansion faces the alley to the south. The materials and detailing are the same as the primary façade. The western mass over the long gable features two bays of fenestration and a central chimney with stucco finish running from the basement level to the roof. One window bay at the first floor has a wood casement window (two lites by five lites). The window opening in the opposite bay has intact wood trim, however the sash has been removed and covered over due to damage from a building fire. At the second-floor level, there is one rectangular window opening with intact wood trim, also covered due to fire damage. Ghosting in the stucco façade opposite this window suggests a window in this bay was present at some time. The third floor contains two small quarter-round wood windows flanking the chimney. A basement access door and basement window, respectively in each bay, have been covered over.

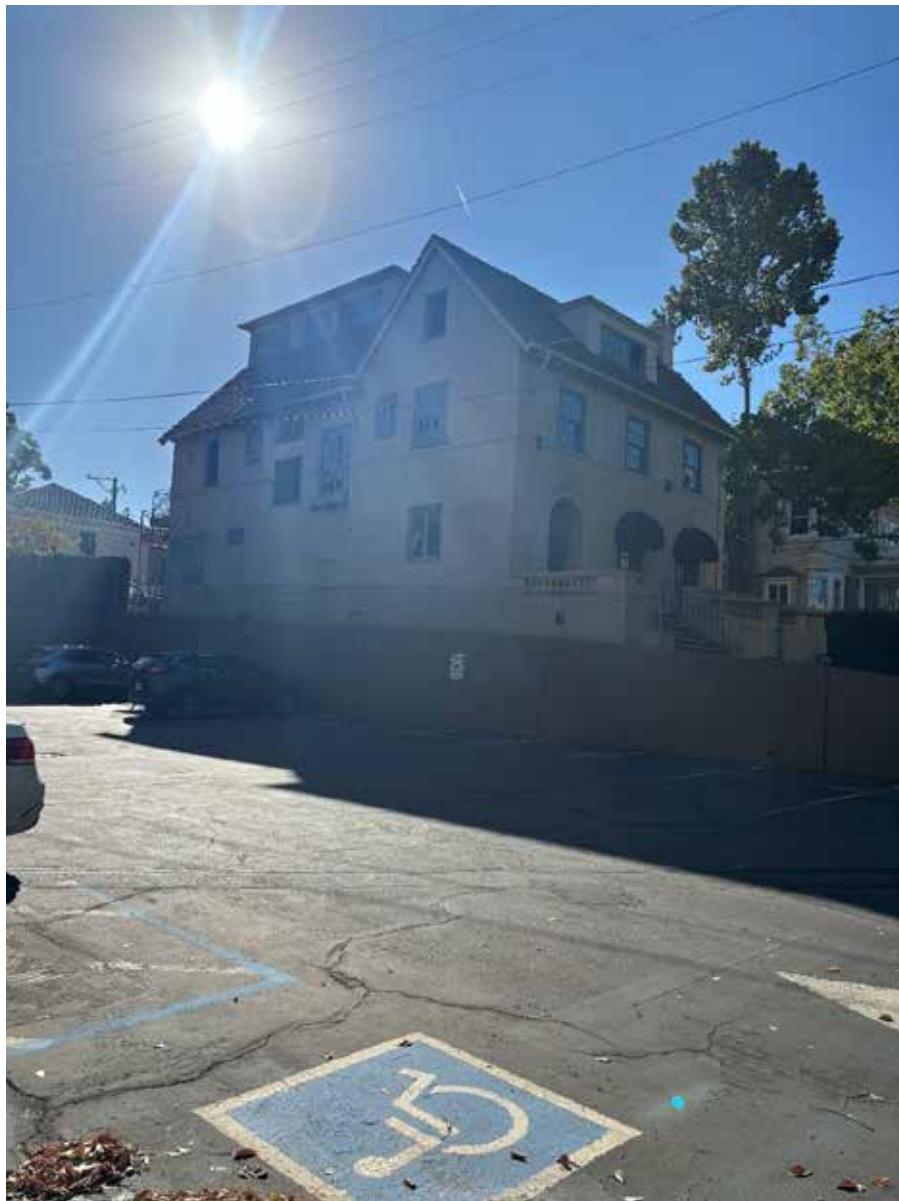
No. 007: West and North Elevations of Briggs Mansion, looking southeast.

The north façade of the mansion contains the same materials and detailing as the primary façade. The exposed rafter tails display fire damage. The facade has a less organized grouping of bays than the primary building façades. The western mass has a central first floor window- a double casement window with leaded glass that has been warped by fire damage. The second floor has a double casement wood window (each sash two lites over four lites) with a smaller casement window to the east (each sash one lite over three lites). Above this at the third-floor level is a centered wood window opening with a missing sash. The eastern mass of the cross gable displays various boarded window openings at the three lower floors. A large glass block window sits at the easternmost bay of the façade at the first floor (a later addition). A large wood casement window with a corbeled window box is situated at the westernmost bay of the second floor. The fenestration at the dormer at the third-floor level is a symmetrical mirror of the south façade of the dormer.

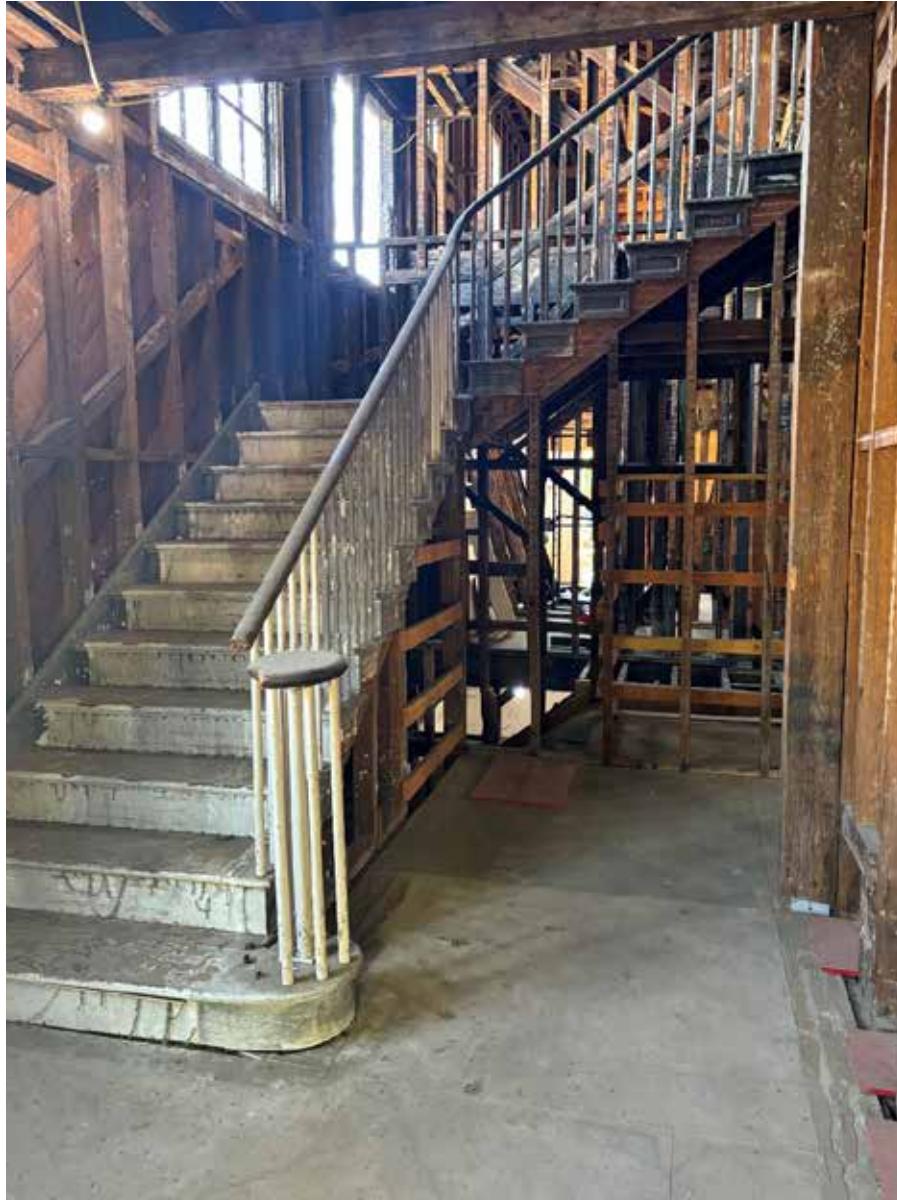
No. 008: Entry way and main stair at first floor interior, facing east.

At the first floor, the interior staircase leading to the second floor is original and possesses decorative qualities but is in poor shape due to fire damage. The staircase has a broken volute railing at the bottom newel post, polished wood handrails with slim, tapered wood spindles and stairs with molded nosings. A brick fireplace is located in the southwest segment of the mansion along the south wall. The only other intact notable feature at the first-floor level is remnants of the ceiling framing for a barrel-vaulted ceiling in the southeast corner.

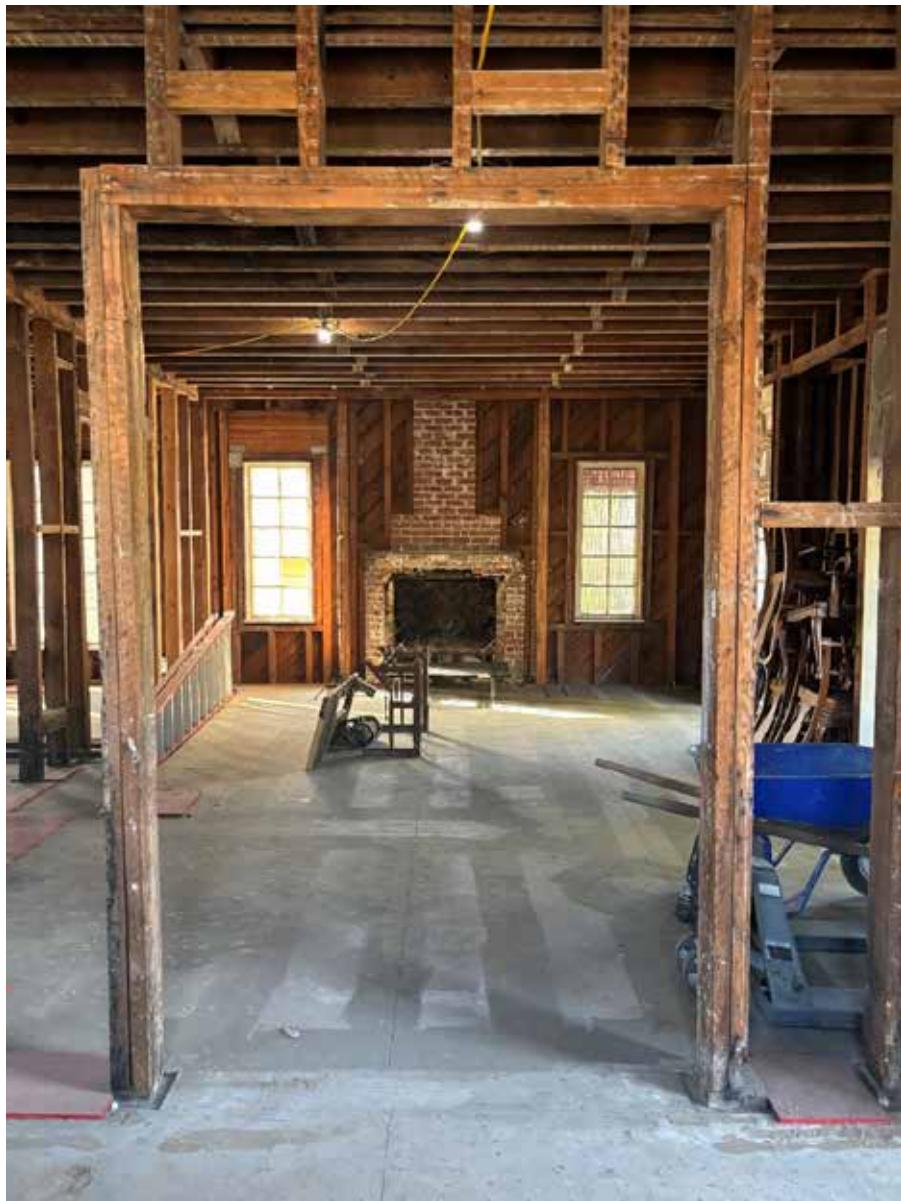
No. 009: Typical interior conditions at first floor with fireplace in background, looking south.

Damage from multiple fires (most recently in 2015) have destroyed a large portion of the building interiors- few architectural features remain, and minimal finishes are intact. Walls have been cleared down to the studs and subfloors and ceiling framing are exposed.

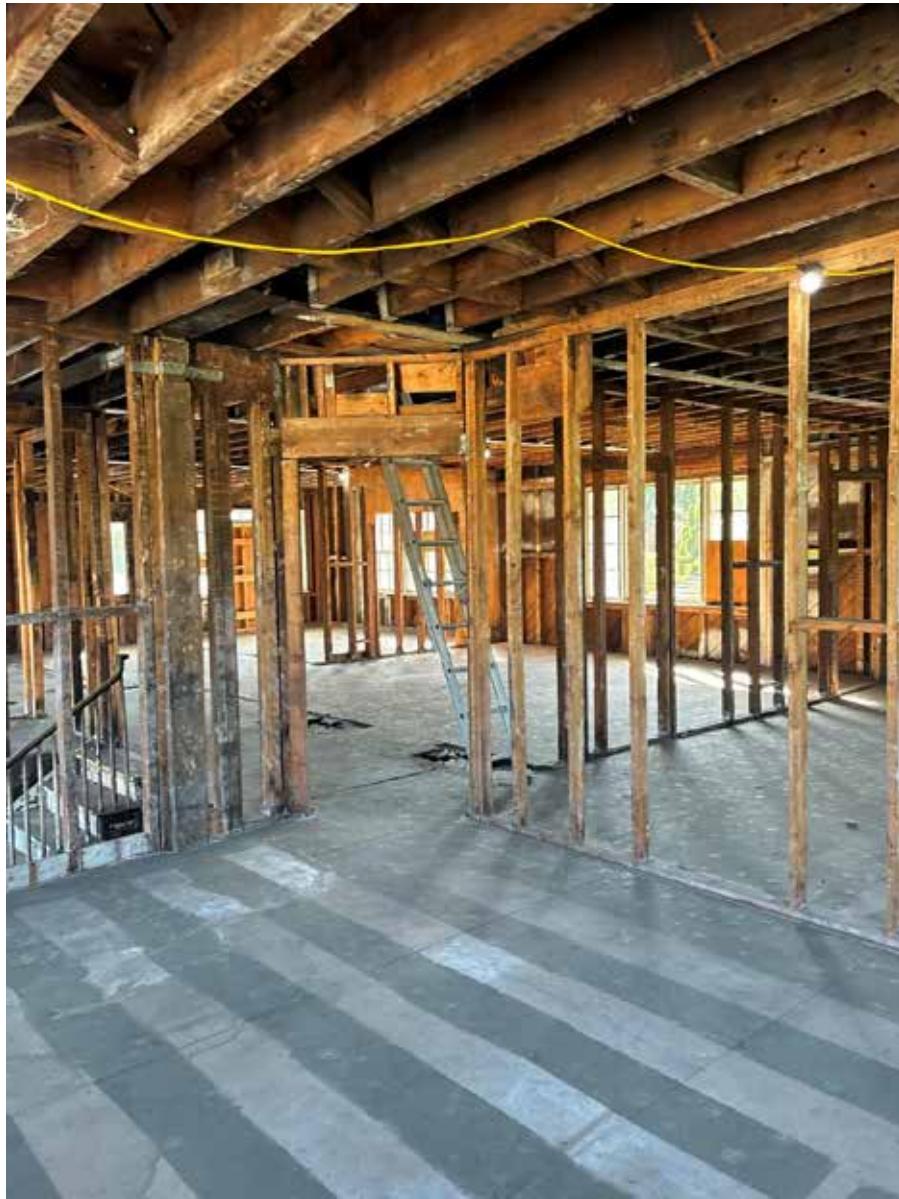
No. 010: Typical interior conditions at second floor, looking southeast.

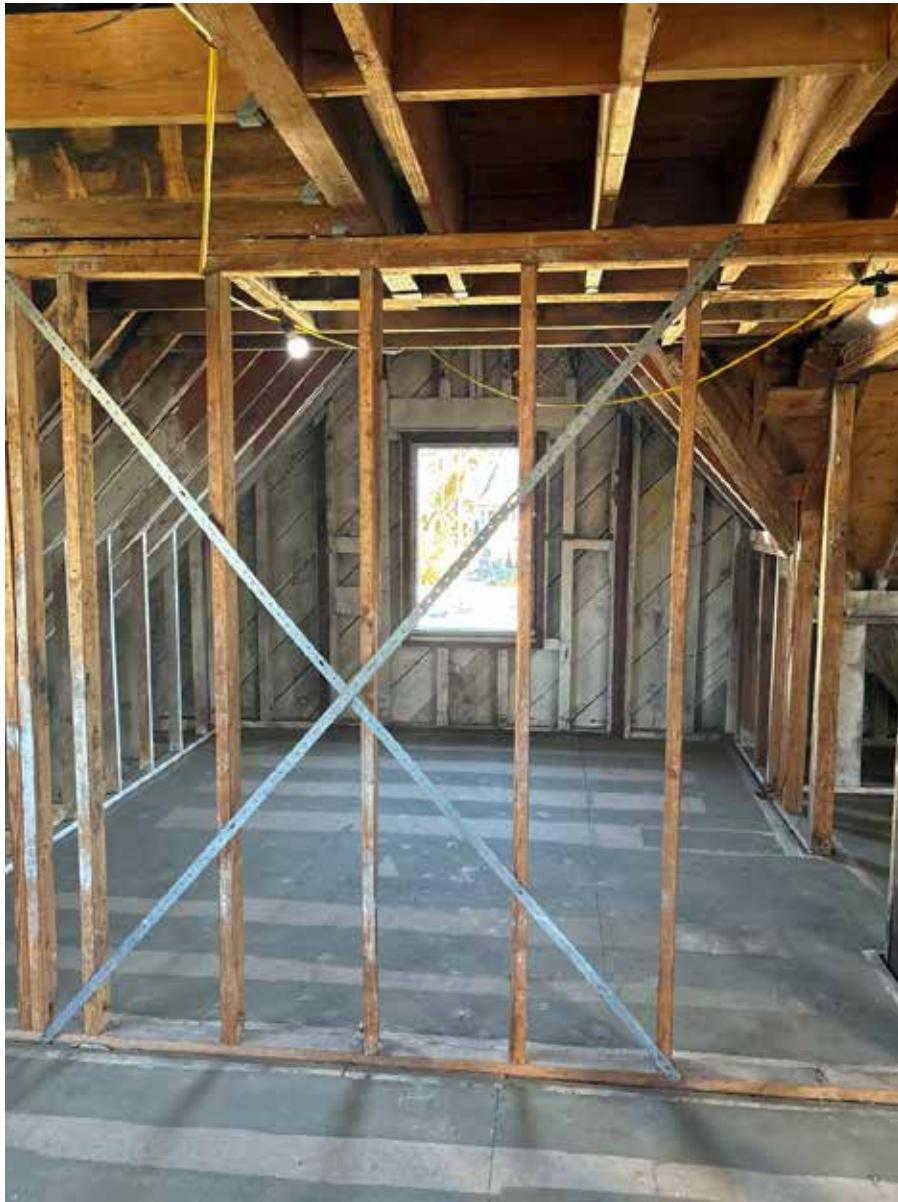
No. 011: Typical third floor conditions, facing north.

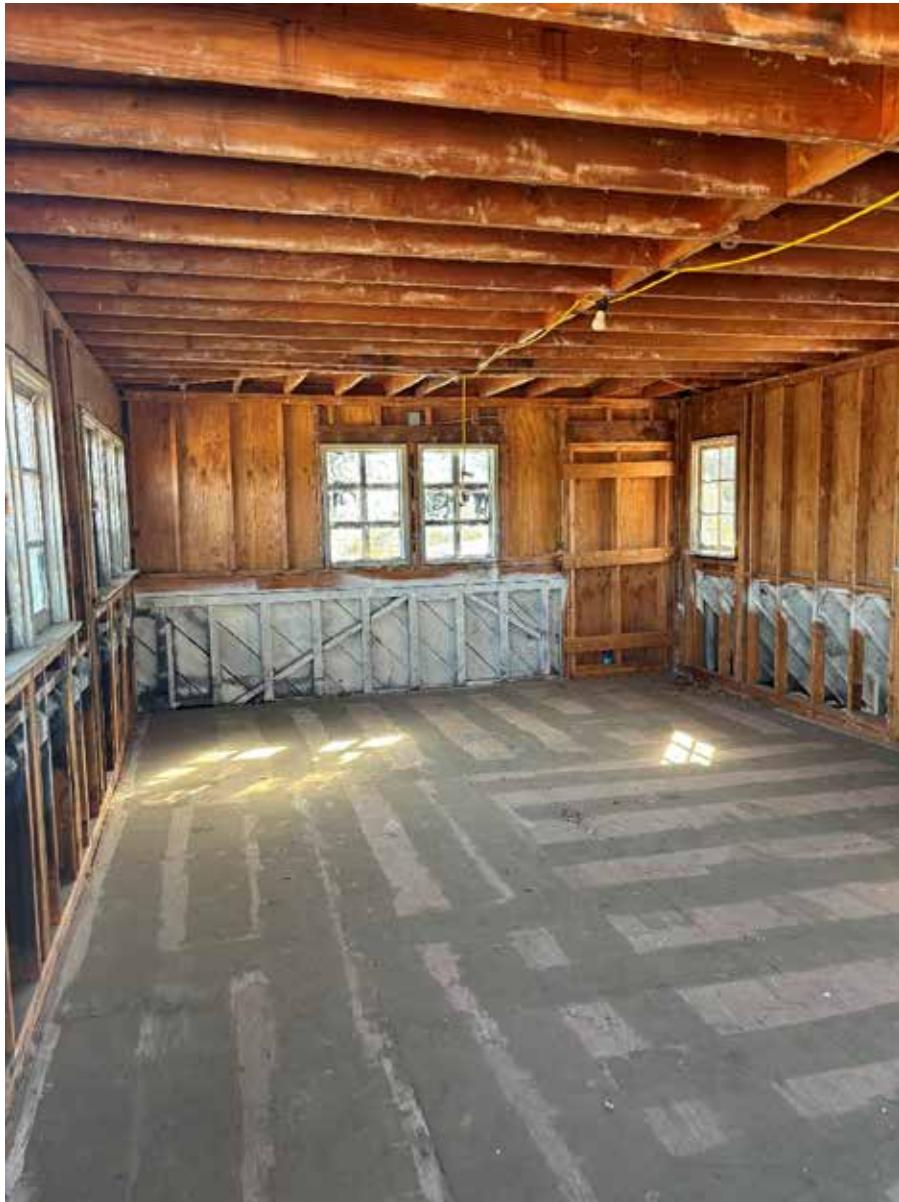
No. 012: Typical fourth floor conditions, looking east.
