# **Carnegie SVRA**

## **Storm Water Management Program**

### **2023 Annual Report**

**Date: March 2024**

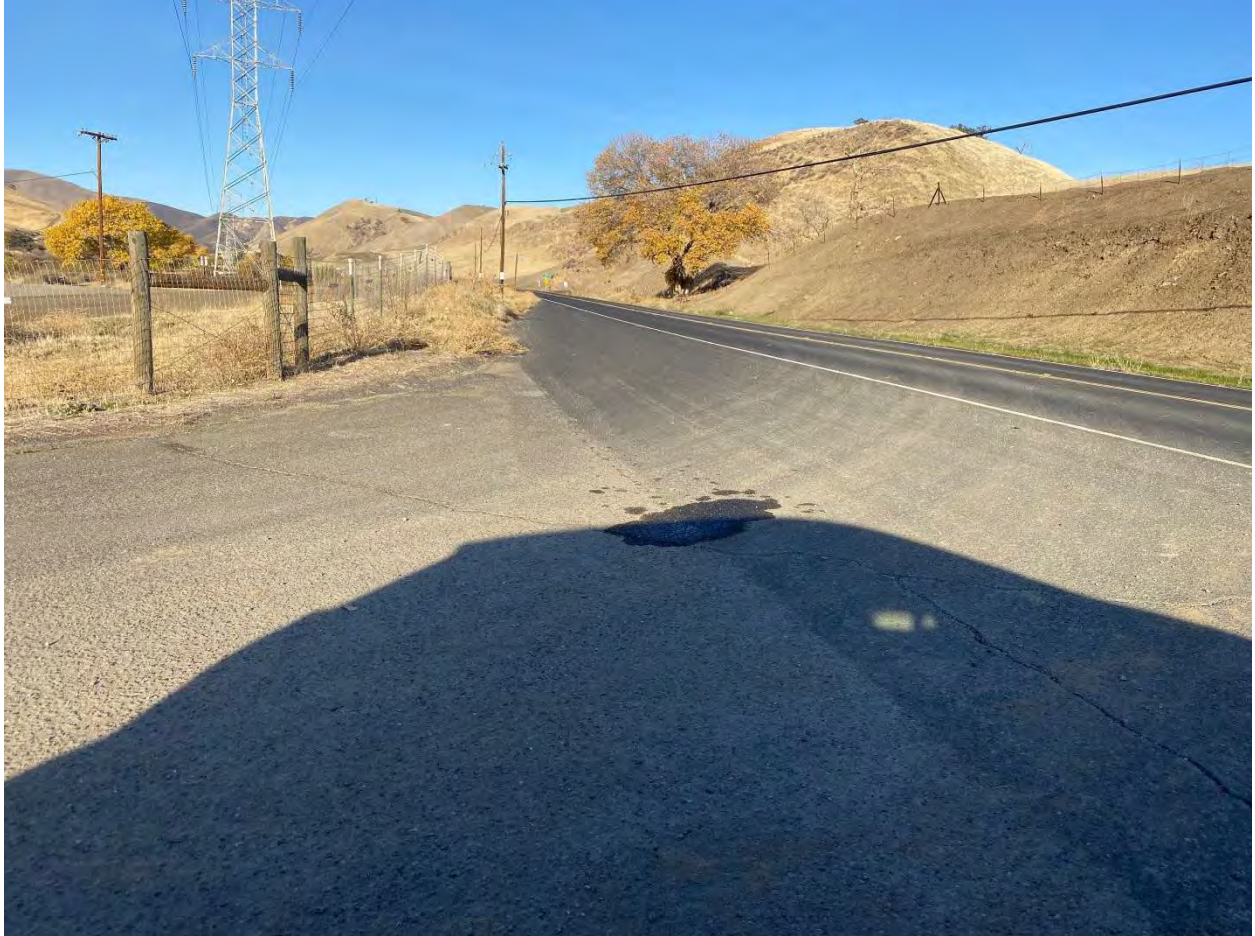
Photo 1: Spill identified at 8:30 am on 11/23/22 outside of entrance to maintenance gate.

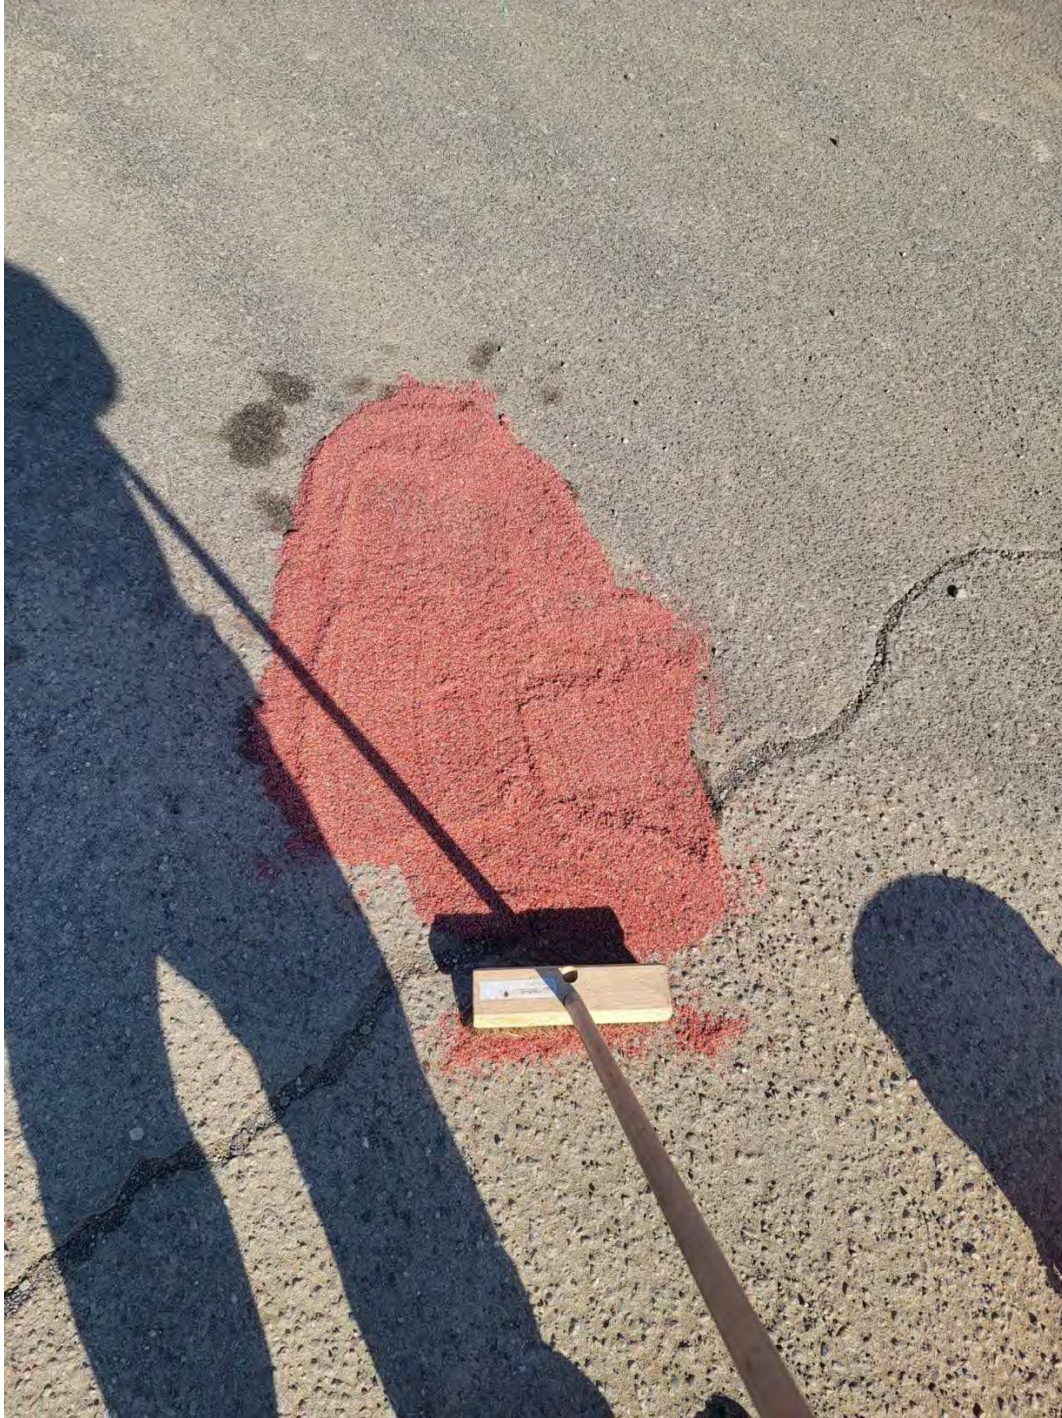
Photo 2: Spill being cleaned up with floor sweep by Parks staff.

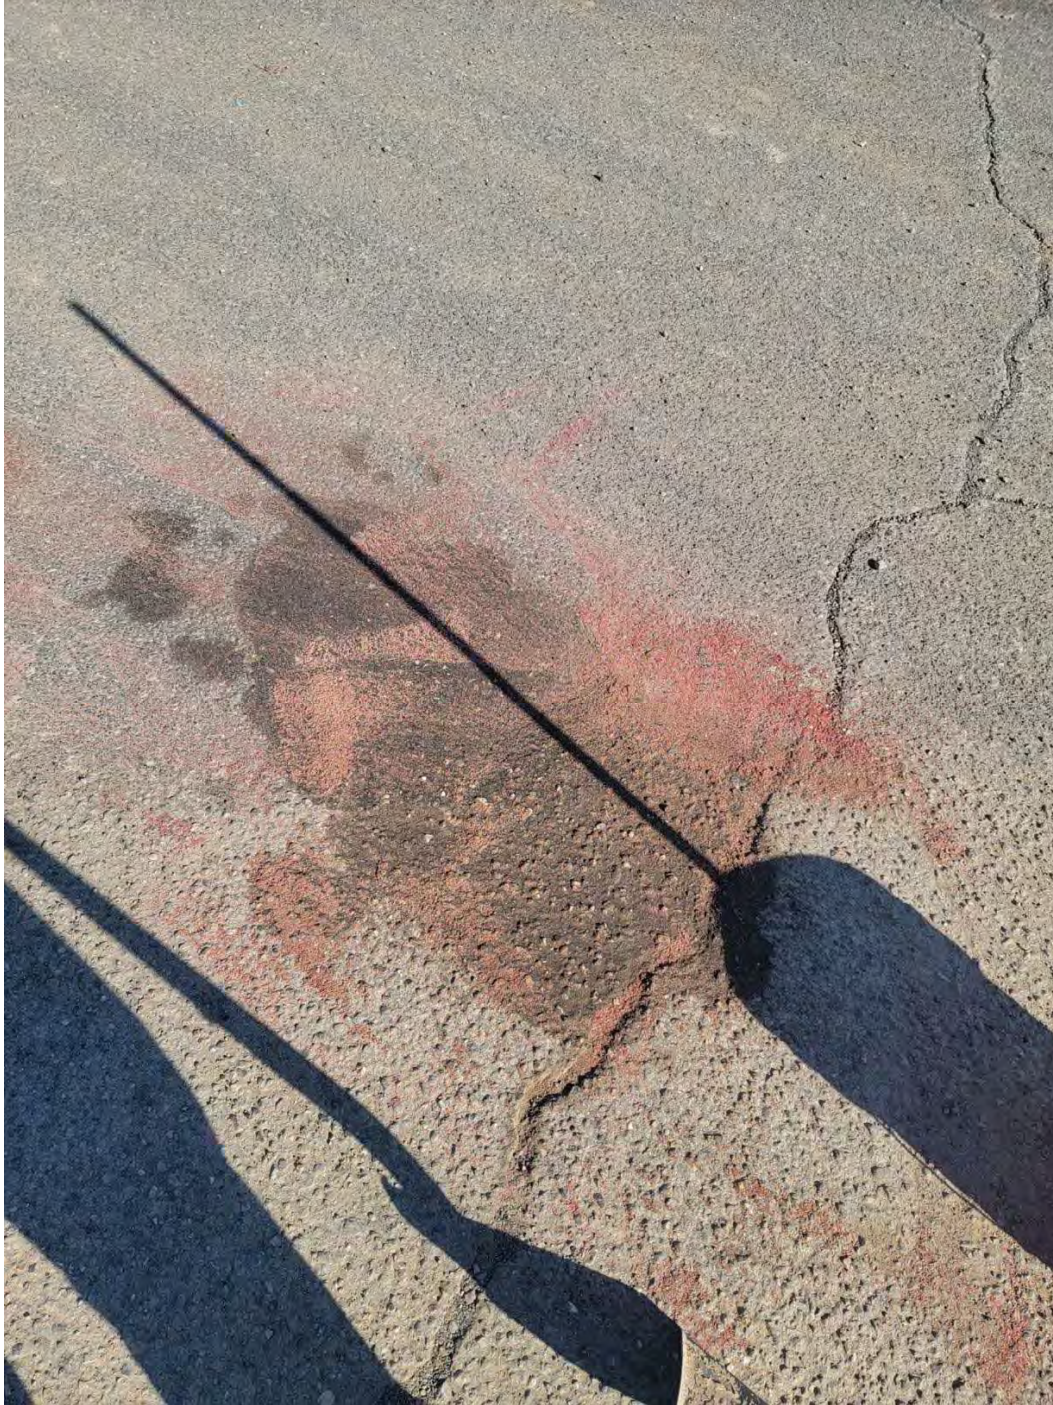
Photo 3: After clean up.

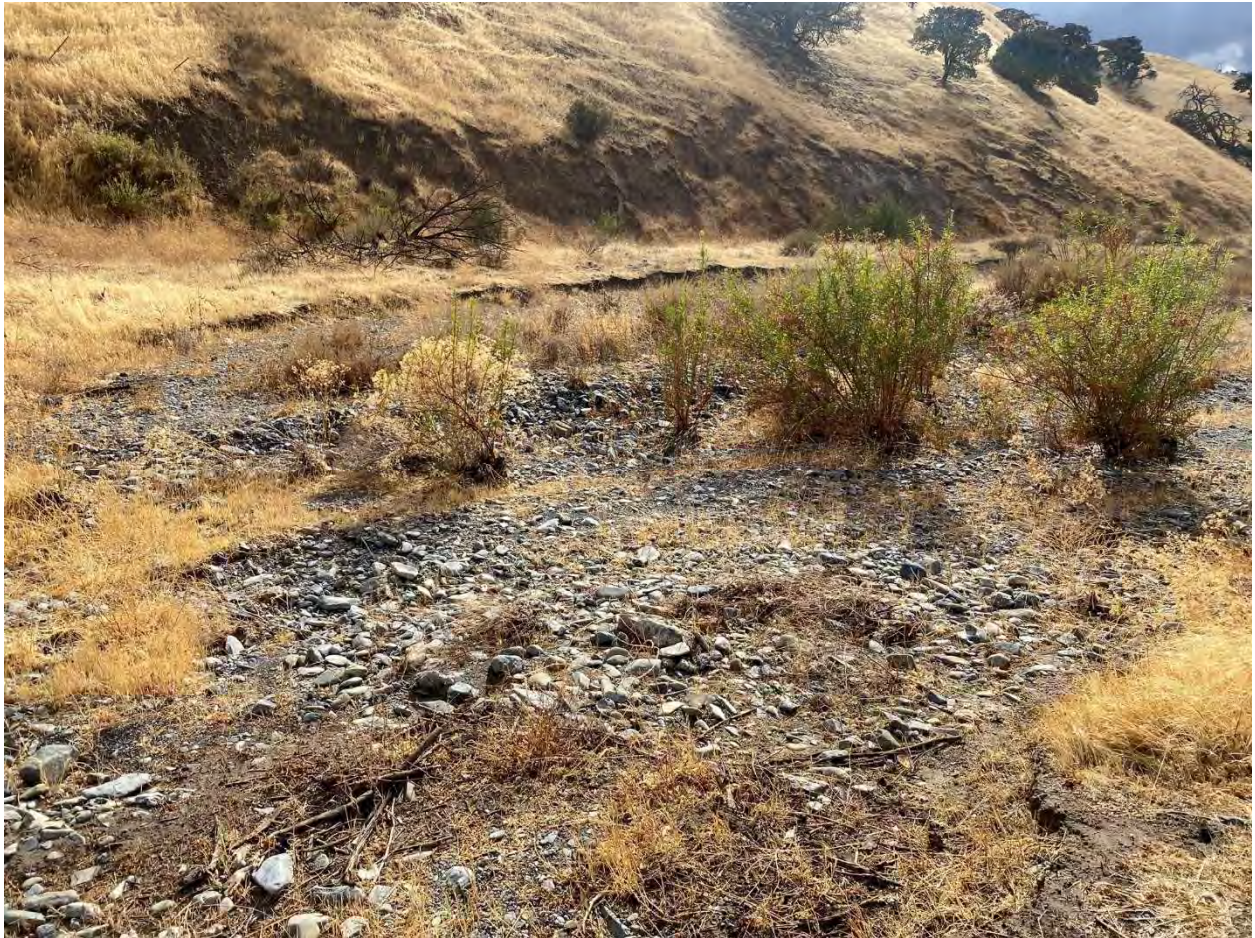
Photo 1: CHC In. No Flow.

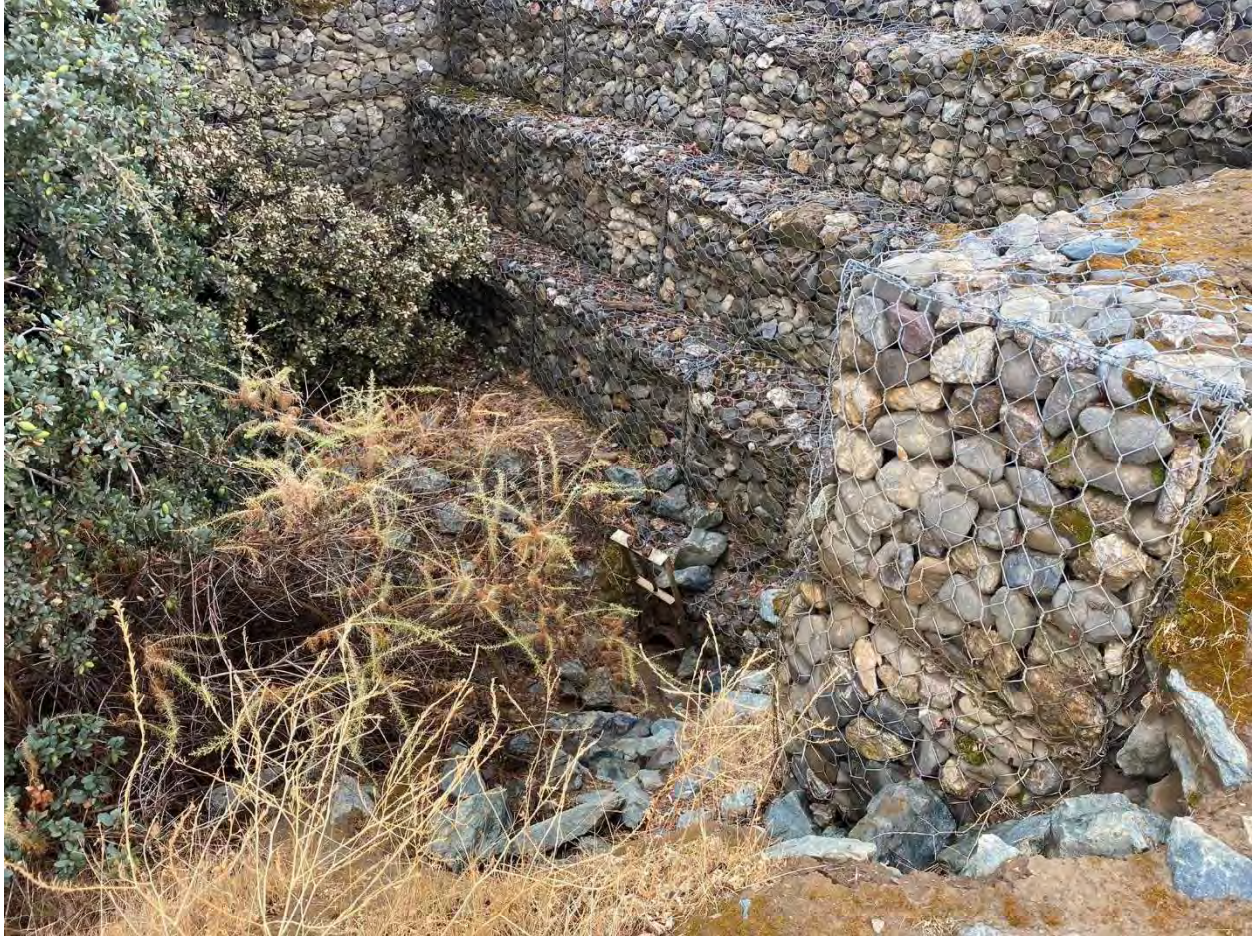
Photo 3: Tyson's Out. No Flow.

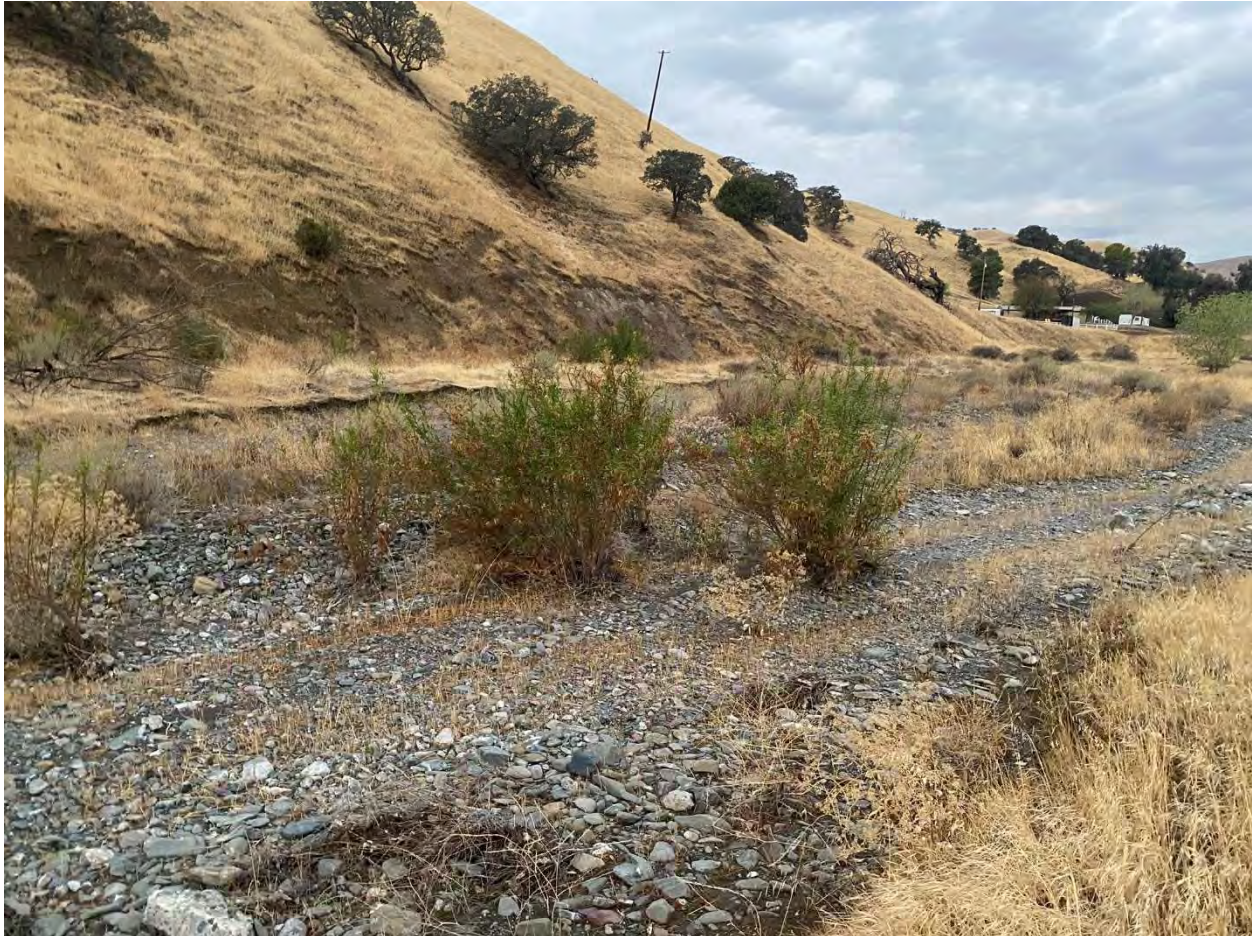
**Photo 1: CHC inlet. No flow.**

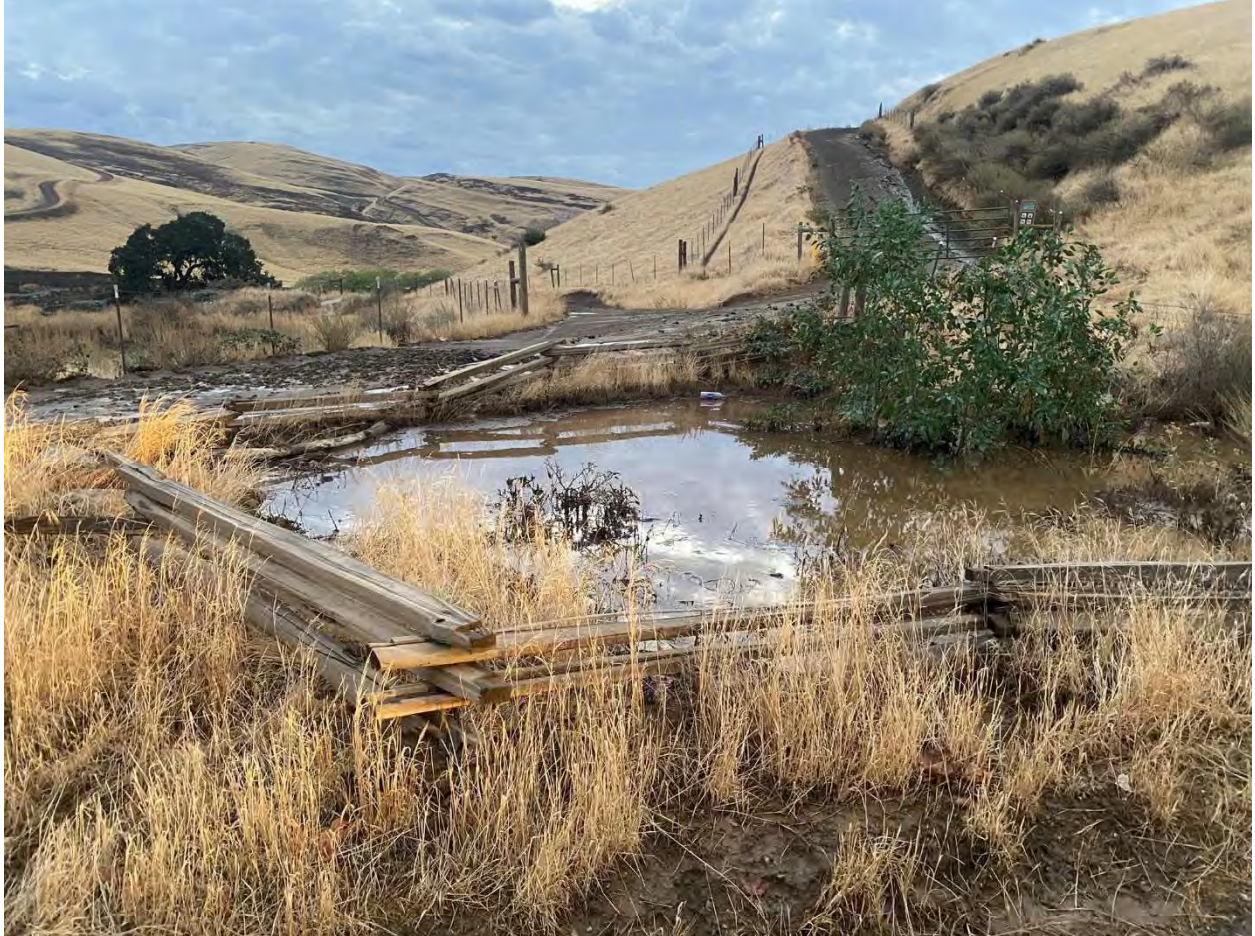
**Photo 2: Tyson's Basin inlet. No flow. Culvert is plugged.**

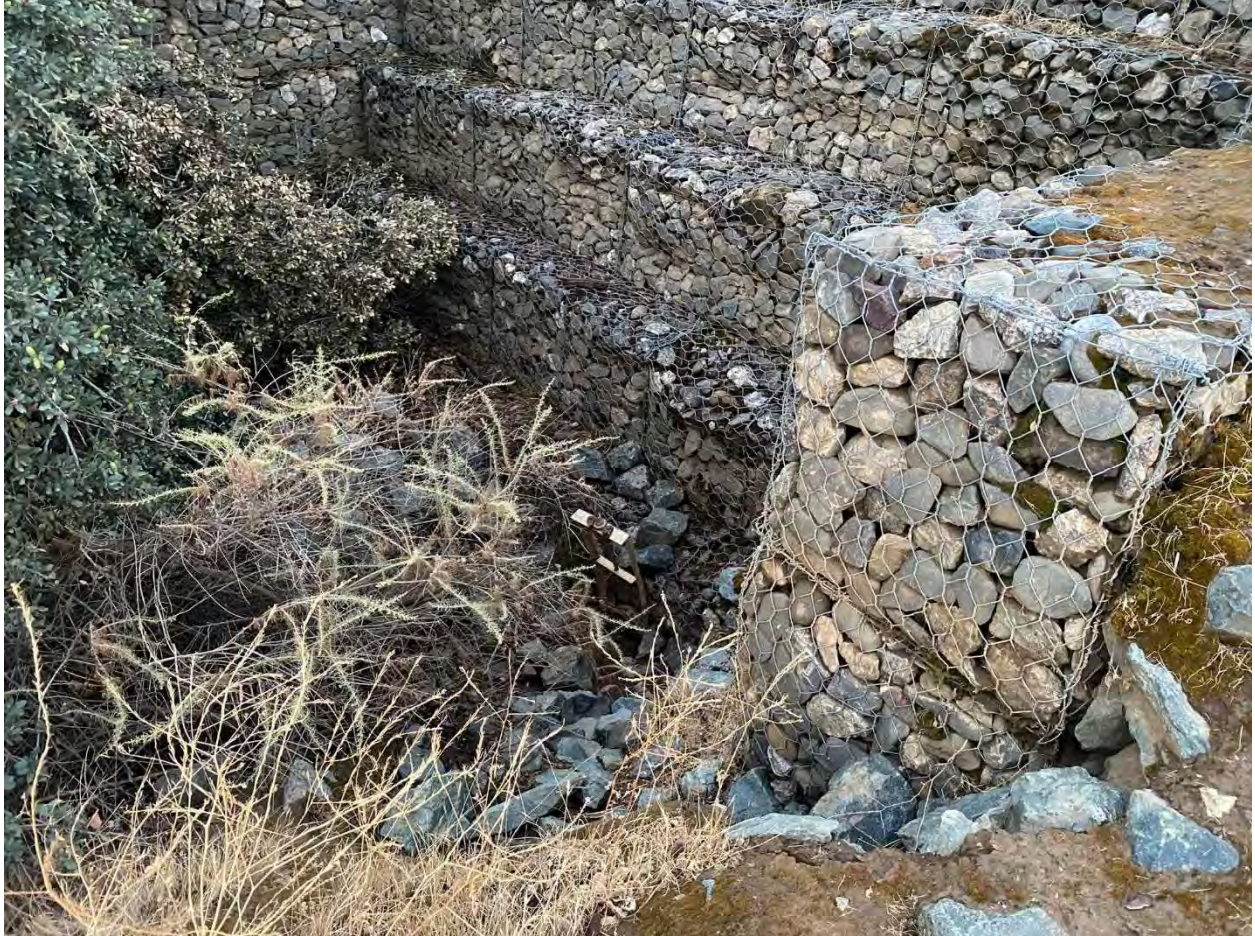
**Photo 3: Tyson's Basin outlet. No flow.**

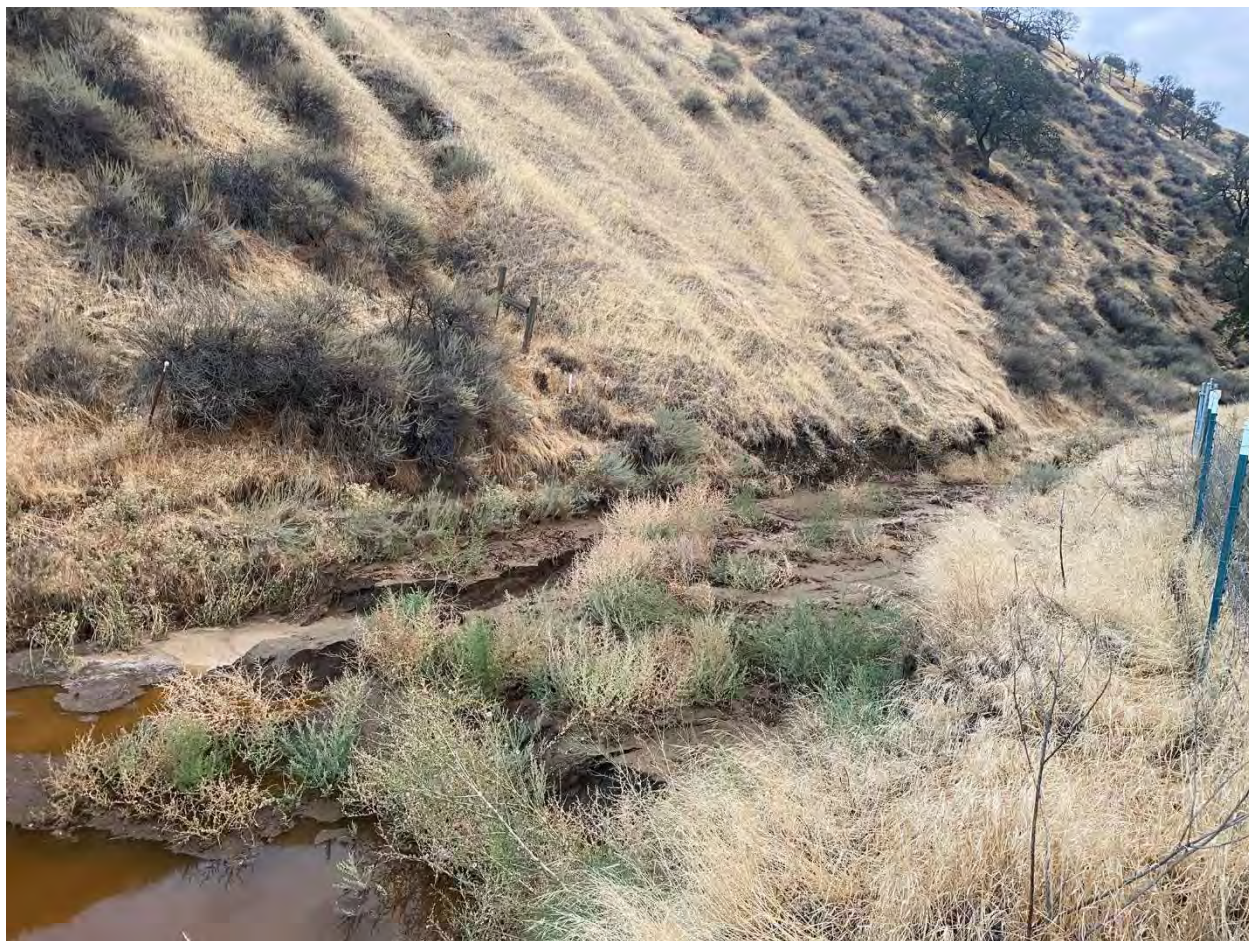
**Photo 4: Carrel's inlet. No flow.**

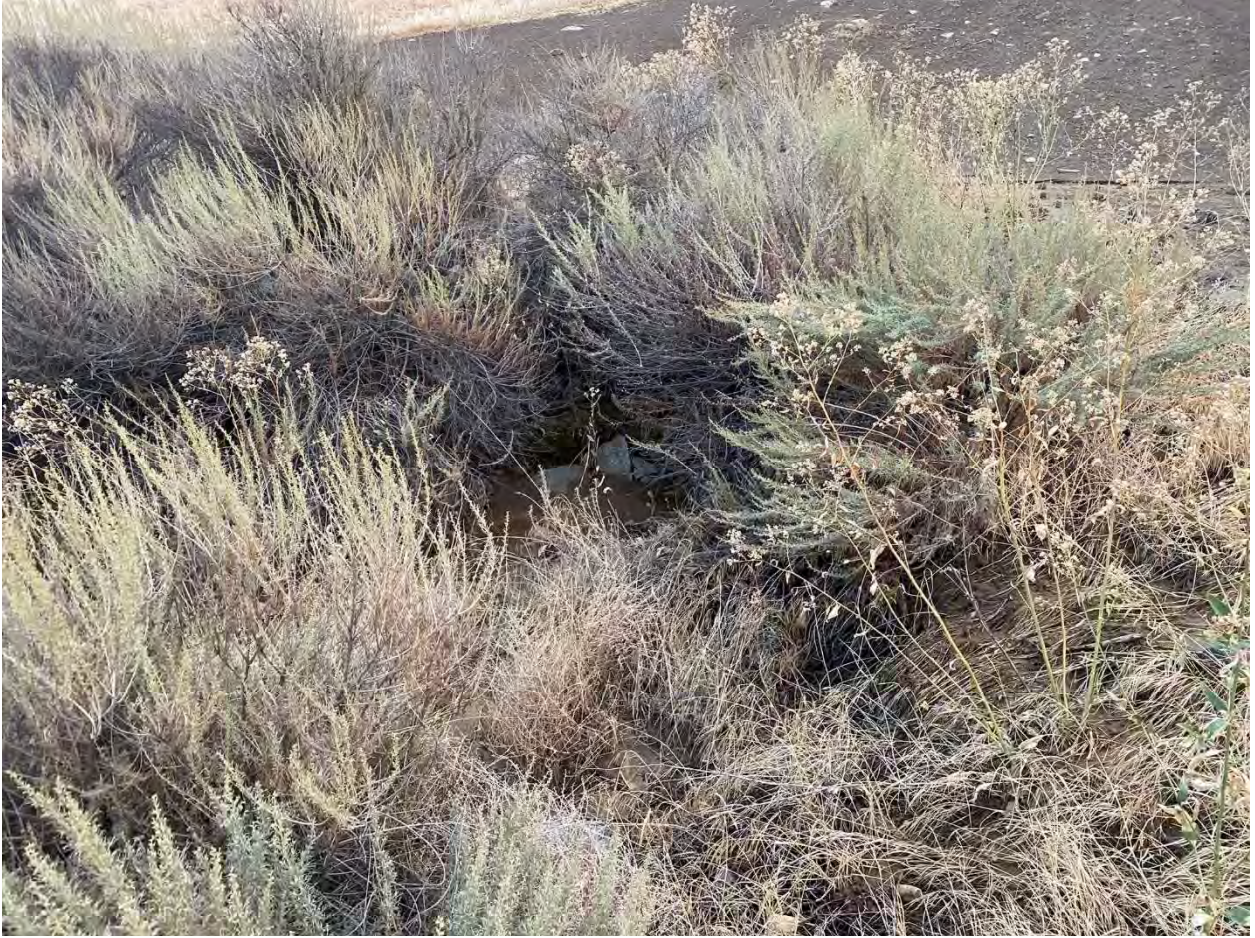
**Photo 5: Carrel's outlet. No flow.**

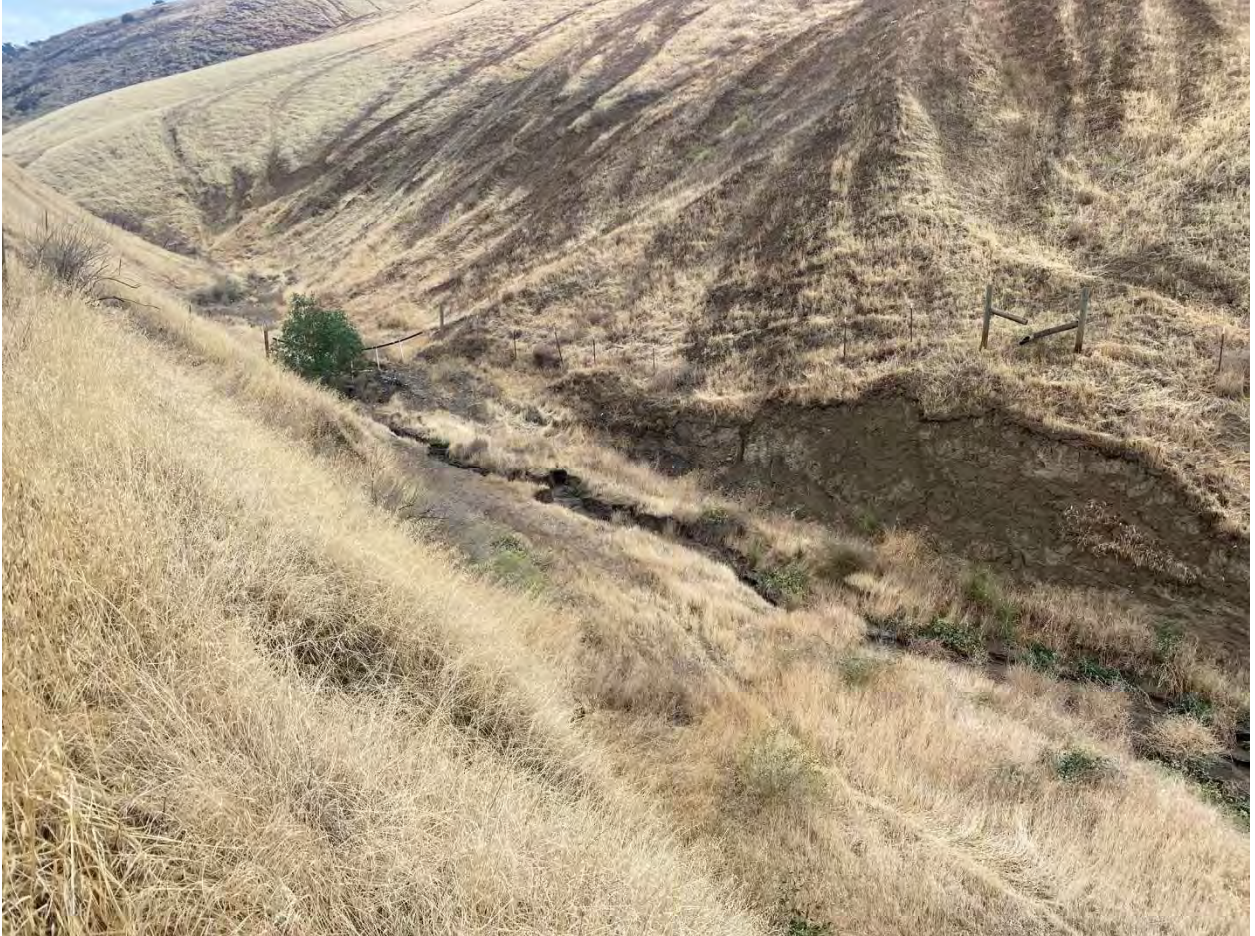
**Photo 6: Kiln inlet. No flow.**

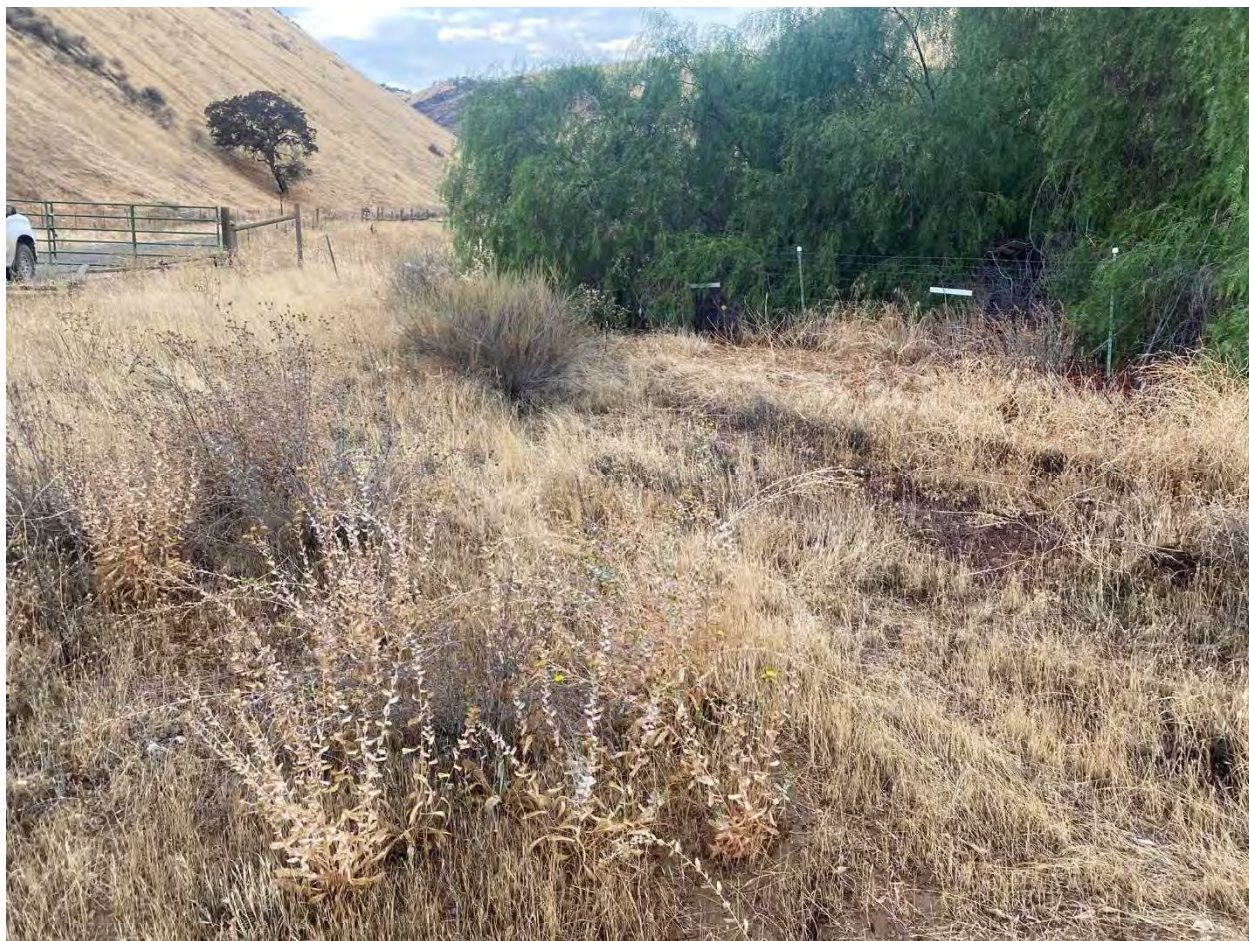
**Photo 7: Kiln outlet. No flow.**

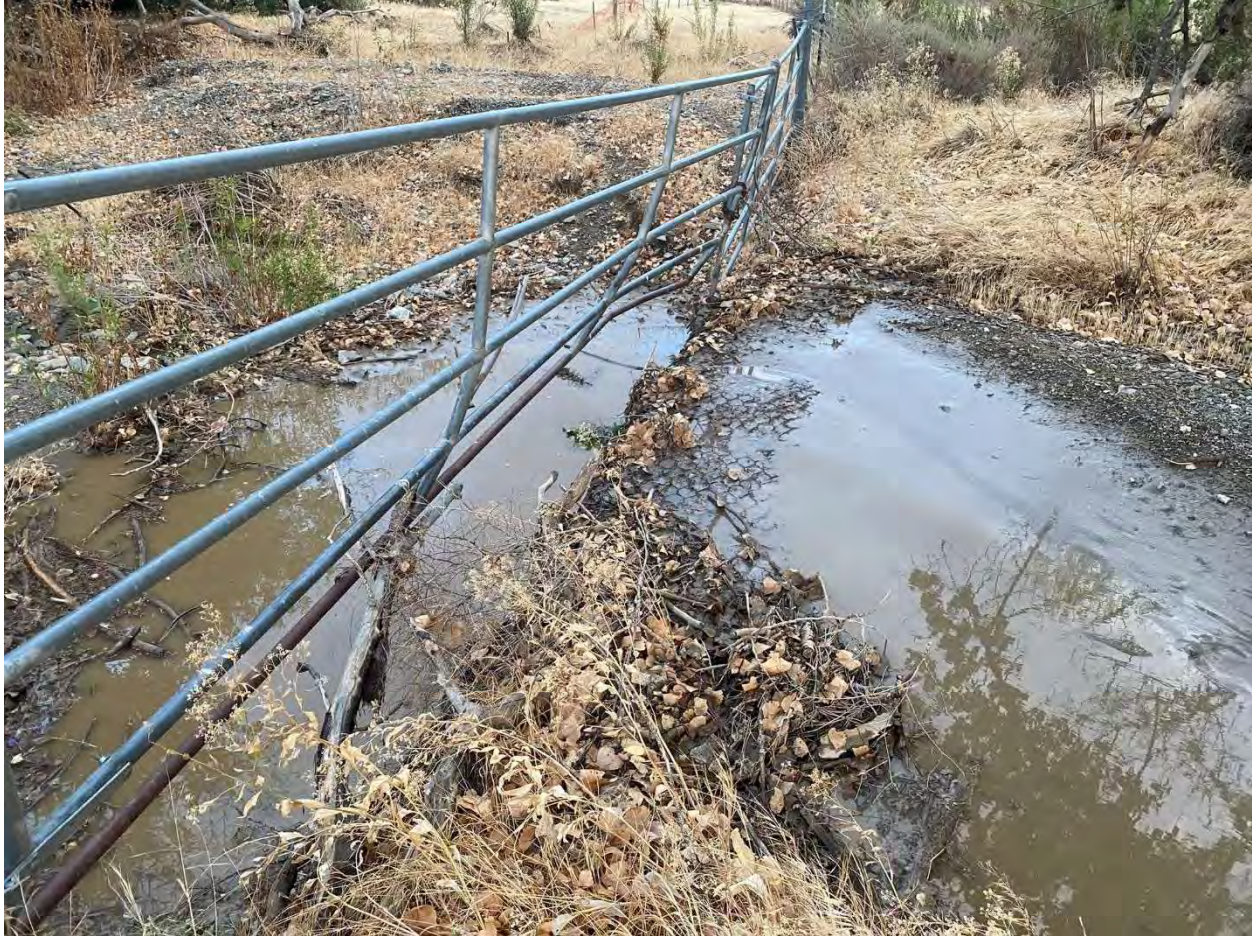
**Photo 8: CHC outlet. No flow.**

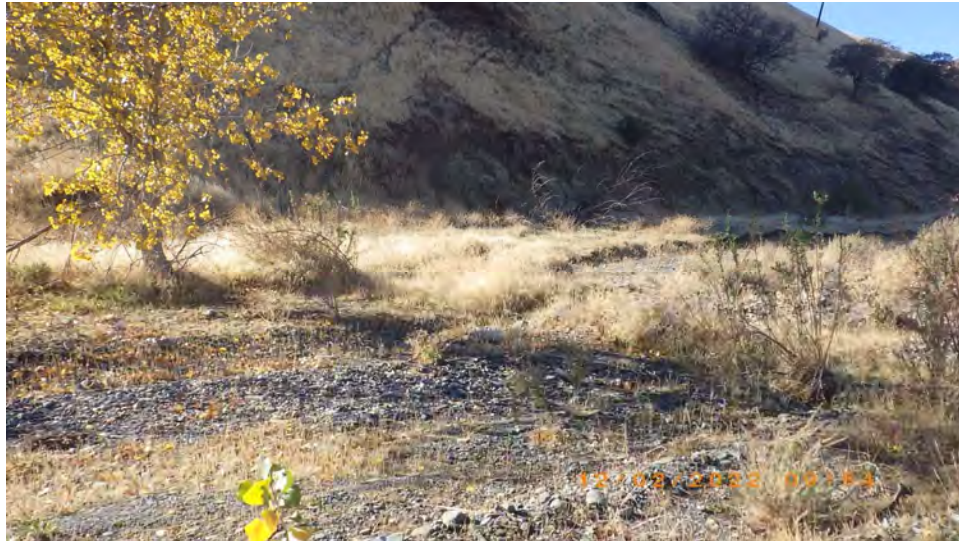
Photo 1: CHC in. No flow, no sample taken.

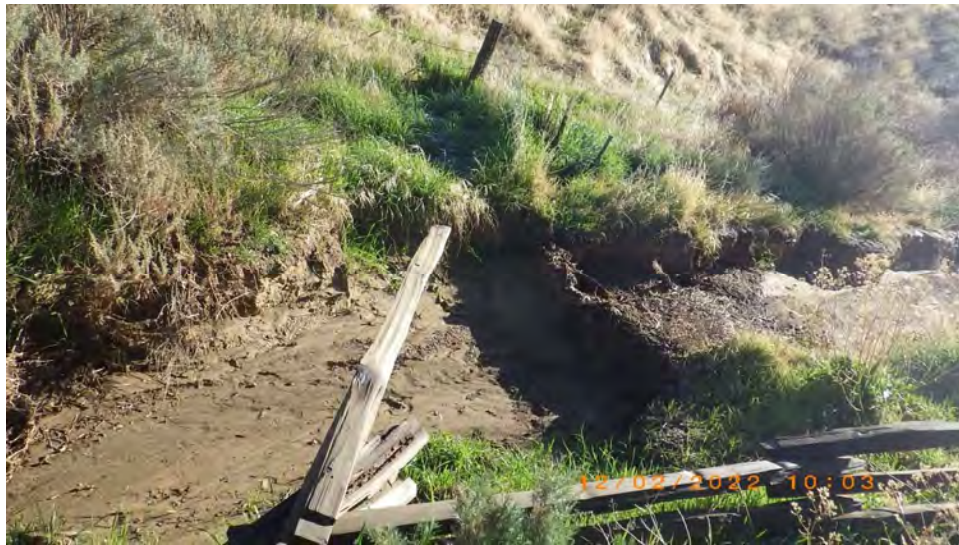
Photo 2: Tyson in. No flow, no sample taken.

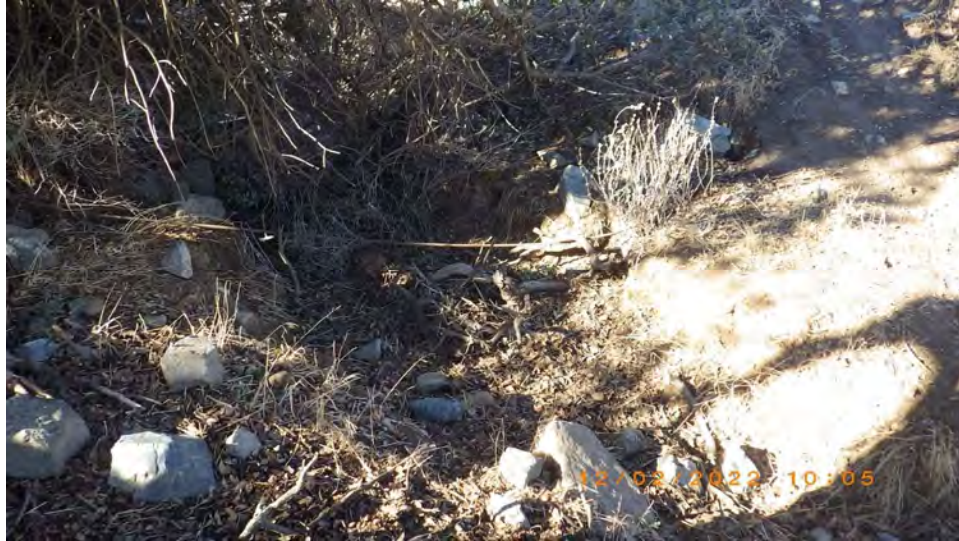
Photo 3: Tyson out. No flow, no sample taken.

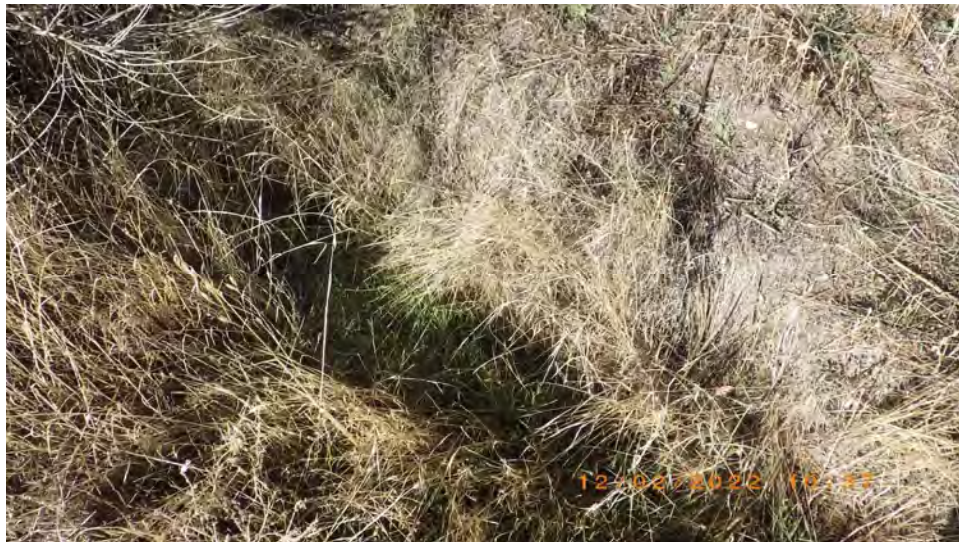
Photo 6: Kiln out. No flow, no sample taken.

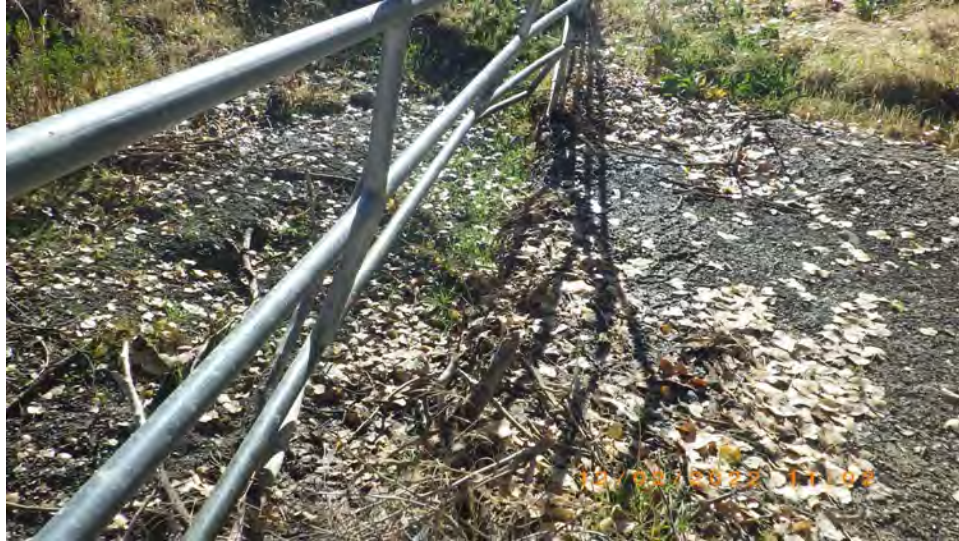
Photo 7: CHC out. No flow, no sample taken.
